PRE-LOAD TEST EVALUATION RESULTS

PERFORMED AT: **B1**
side
1-4 Brightwood Terrace Lynn MA

INSPECTION DATE **July 1 2025**
REPORT DATE **July 7 2025**
REPORT EXPIRES **August 7 2025**

PRE-LOAD TEST INITIAL EVALUATION PASS/FAIL REPORT

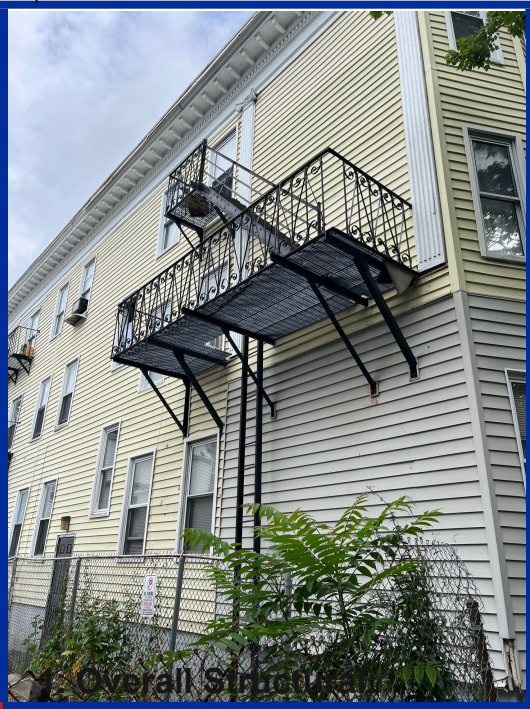
- **Type of structure:** 3 story wood building.
- **Estimated system age:** Mixed system with original rivets and square bolts; updated sections include new hex bolts.
- **Pre-1978 Status:** Presumed to predate 1978; lead paint safety measures recommended.

Paint: Failure Rate – 0–25% – System was found to have more paint than rust. Minor surface corrosion present due to incomplete coverage and lack of sealing/caulking at joints. We recommend spot painting and caulking the system. Lead paint presumption applies.

Supports: Failure Rate – 0–25% – Original supports are fair and functional. Minor internal rust noted at some unsealed joints due to missing caulking. This component was reinforced with new hex bolts, replacing original rivets and/or square head bolts, significantly improving the reliability of structural connections. Structurally sound at time of inspection, ready for load testing.

Rails: Failure Rate – 0–25% – Railings generally functional with minor internal rust observed in connections due to lack of sealant, including at scrolls and welded joints. This component was reinforced with new hex bolts, replacing original rivets and/or square head bolts, significantly improving the reliability of structural connections. One barrier section missing near the fold-out ladder poses a safety issue.

Platforms: Failure Rate – 0–25% – Old platform gratings were replaced with new grating and j-hooked securely. Some signs of corrosion at junctions due to lack of routine maintenance, but structural condition remains fair.

Stringers: Failure Rate – 0–25% – Secure at both top and bottom connections. Minimal corrosion, with some internal rust beginning to form at unsealed joints. This component was reinforced with new hex bolts, replacing original rivets and/or square head bolts, significantly improving the reliability of structural connections.

Treads: Failure Rate – 0–25% – Old treads were replaced with new welded and clipped treads which remain in good condition. Surface rust and some internal rust at clip connections from lack of sealing. This component was reinforced with new hex bolts, replacing original rivets and/or square head bolts, significantly improving the reliability of structural connections.

Fold-out Ladder: – 25% – Fold-out ladder functional but lacks ground footings and adjacent pit near fold-out ladder poses fall hazard missing a railing barrier, presenting a fall risk.

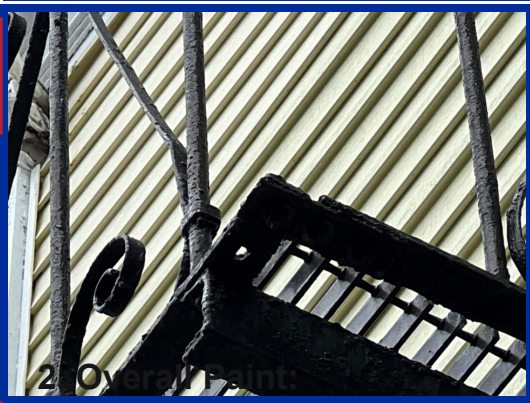
Poor/Fail

0-25%

Overall the paint **PASS: Spot paint** on system recommended before/after repairs. Recommend to power wash and seal all major joints to prevent water intrusion into structural connections.

Fire Escapes, must be maintained/ painted every 5-7 years as per manufactures recommendation.

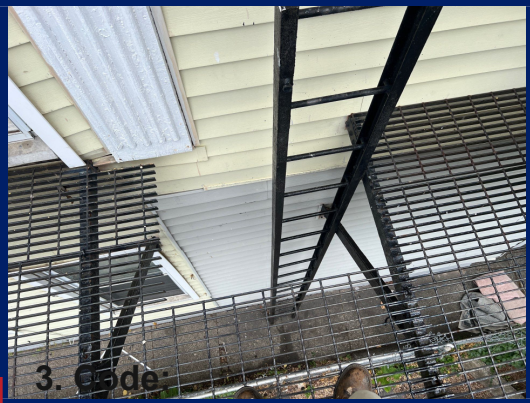
Our inspector found some code issues related to AHJ (Authority Having Jurisdiction) or PENC (pre-existing non-conforming) requirements for this Fire Escape system:

- **Lack of Lighting:** The fire escape lacks adequate illumination, violating IFC 1008.2 which requires means of egress to be illuminated at all times the building is occupied.
- **Obstructions:** Obstructions on the fire escape, violating IFC 1030.2, which mandates that egress paths be unobstructed and maintained in a readily accessible condition.
- **Missing Railing Barrier:** There is a missing safety railing adjacent to the fold-out ladder, creating a fall hazard.

Issues Exist

25%
