Pre-Load Test Evaluation Report -

Pre-Load Test Evaluation by Fire Escape Engineers

Evaluation Date: 10/22/2025

Building Description: 6-story brick structure with 7 system(s) on the building.

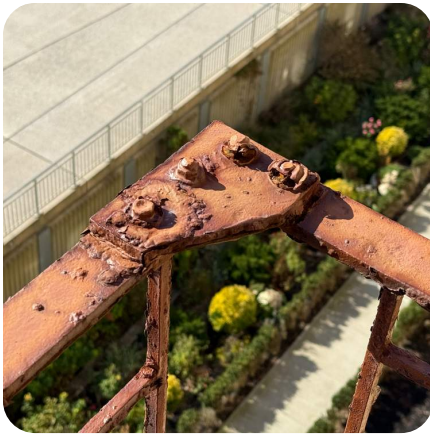
Corroded rail gusset plate connection

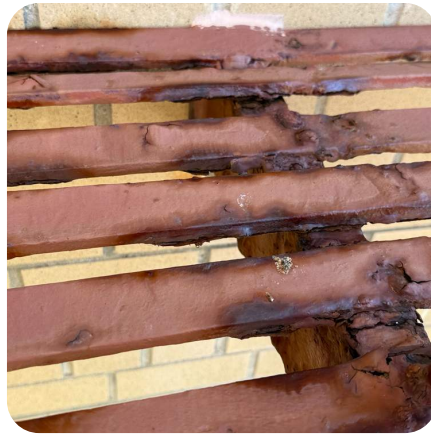
Corroded slat connections

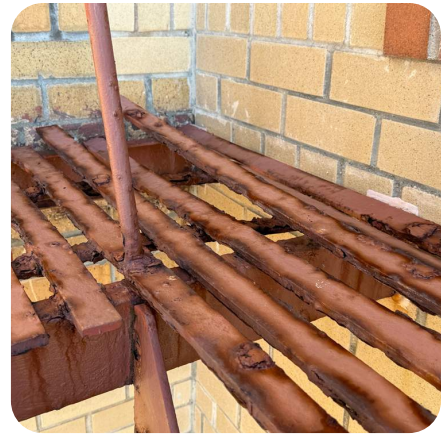
Corroded slat connections, detached - trip hazard

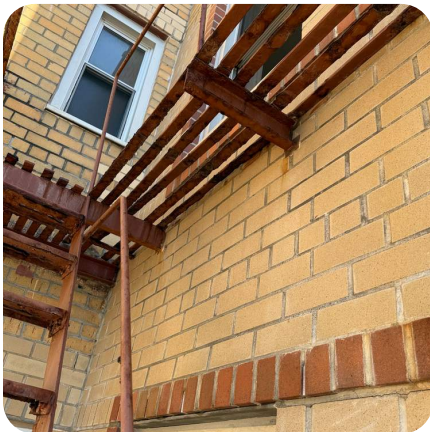
Fair and functional supports, ready for load testing

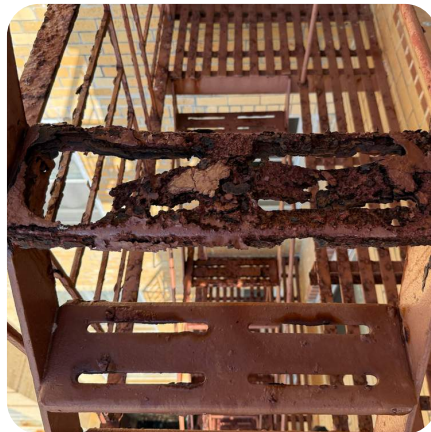
Corroded Tread - Life Safety

Several stair treads exhibit **severe corrosion and material loss**, with signs of brittleness and flaking under moderate pressure. These conditions constitute a **life-safety hazard and imminent danger** to users. All compromised treads must be replaced prior to any load testing or certification.

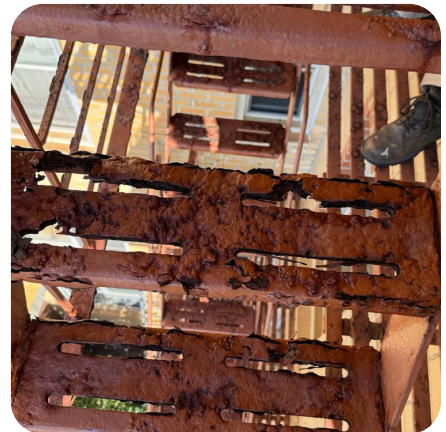
Corroded Tread - Imminent Danger

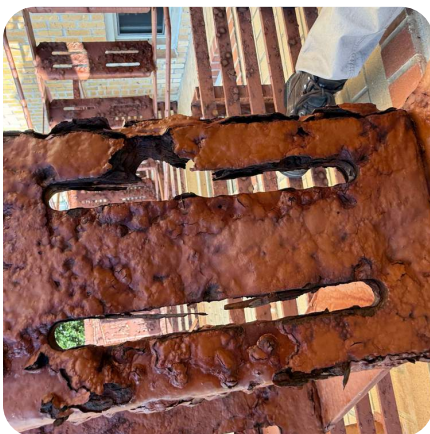
Corroded Tread - Imminent

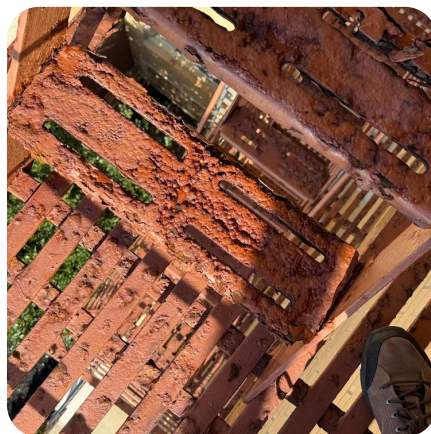
Corroded Tread

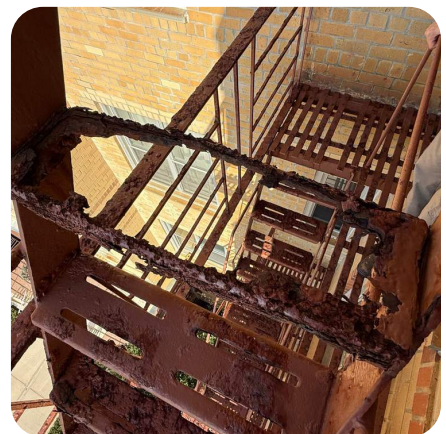
Corroded Tread - Life Safety

Danger

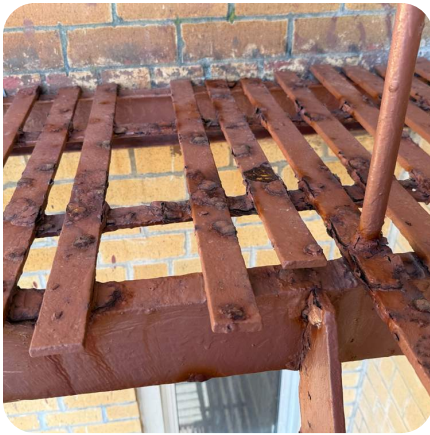
Missing & Corroded Slats -
Imminent Danger

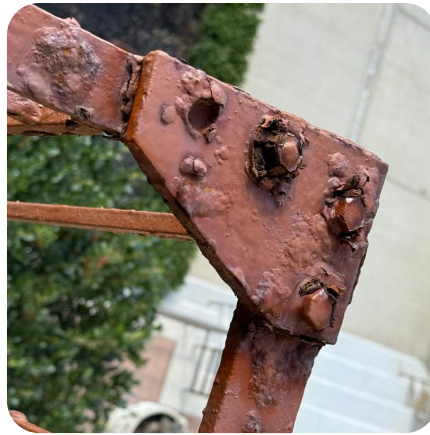
Corroded rail gusset plate
connection

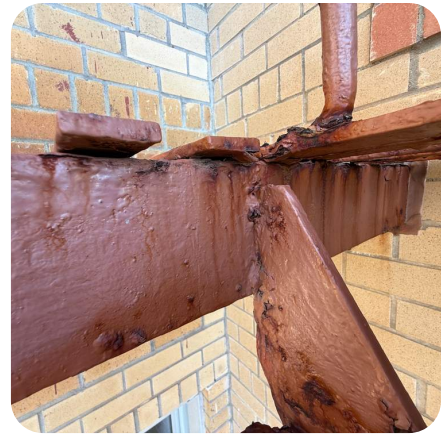
Suspect welded stringer
connection. Missing bolted
clip connection.

Welded stair stringer connections show evidence of surface and internal corrosion. Reinforcement with **bolted clip plates** or equivalent mechanical fastening is recommended to restore load continuity and provide redundancy.

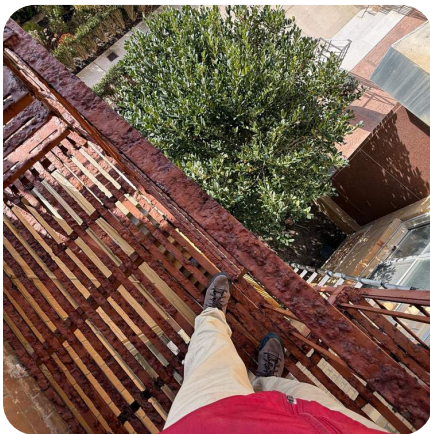
Corroded railings

The guardrails exhibit widespread corrosion, with evidence of **rust-jacking** at several connection points and blistering of the protective coating throughout. Bolted joints display varying degrees of fastener corrosion and internal rust. All railing connections should be cleaned and resecured with new hardware.

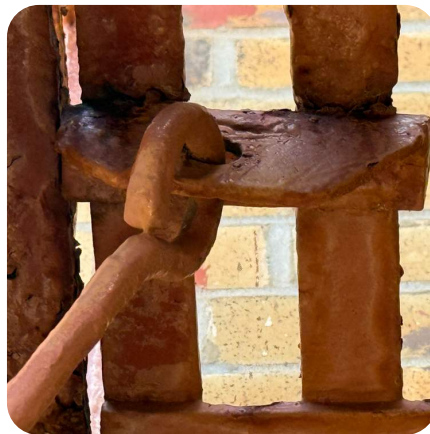
Ladder's release mechanism
suspect with internal rust

The drop ladder was not deployed during the inspection. The upper release mechanism and support hook display minor internal corrosion but appear intact. The assembly is presumed functional but requires operational testing and full surface preparation with a protective coating system.

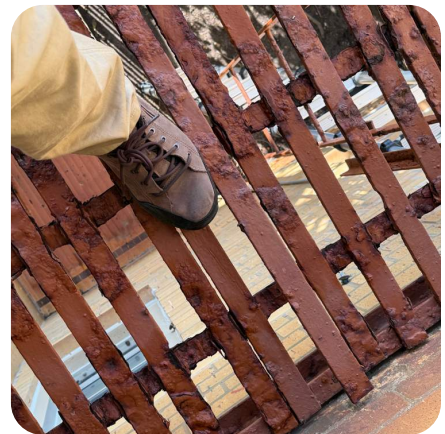
Corroded slats, detached
connections

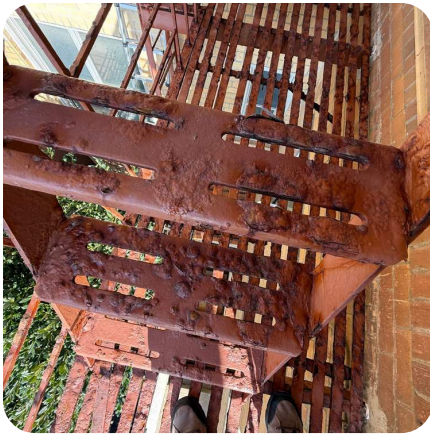
Corroded treads

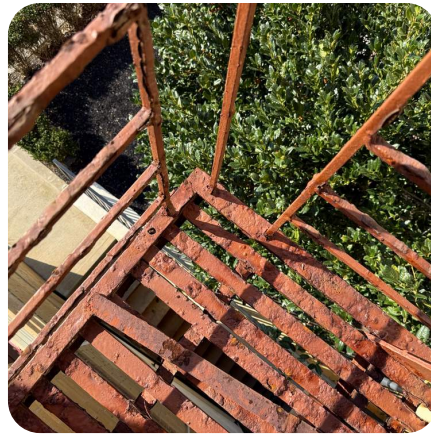
Corroded platforms and rails

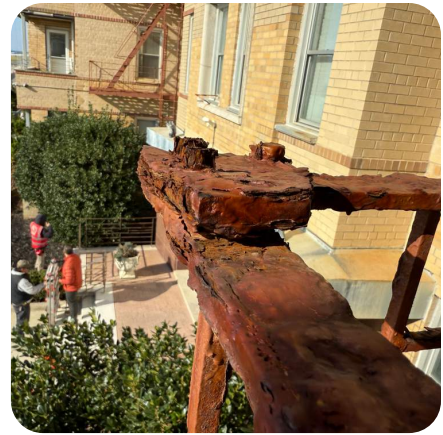
Corroded rail gusset plate connection with rust jacking

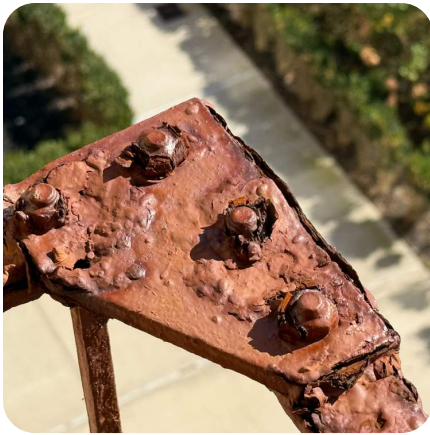
Corroded rail gusset plate connection

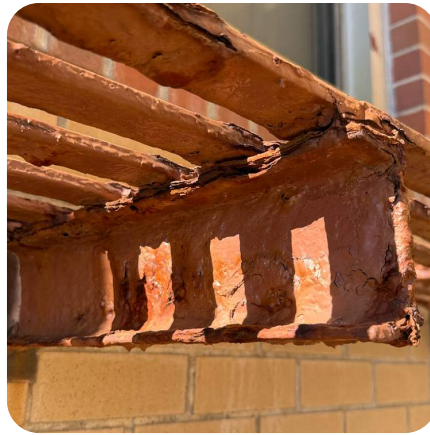
Corroded slat connections

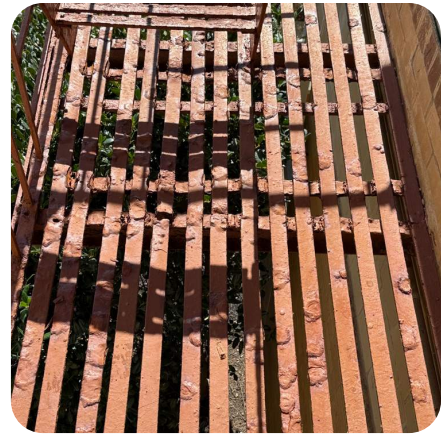
Corroded slat connections, detached - trip hazard

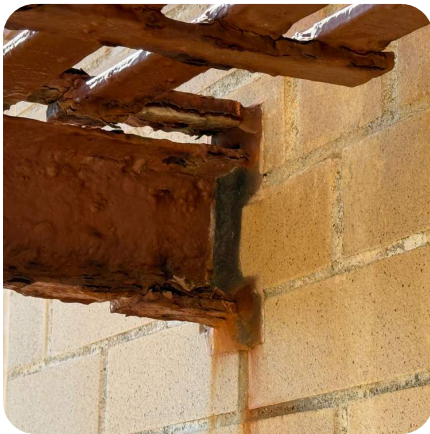
Corroded Support connection

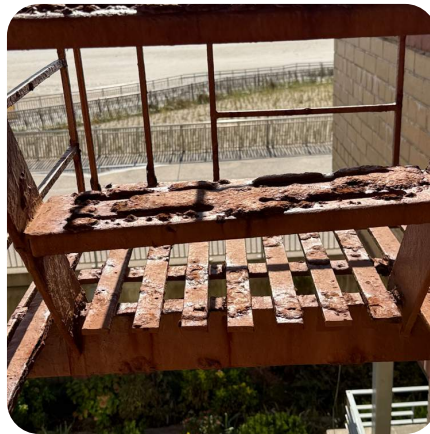
Corroded Tread - Imminent Safety Hazard

All treads should be cleaned and evaluated for remaining section thickness. Severely corroded treads exhibiting brittleness or section loss present an **imminent danger** and must be replaced. Salvageable treads may be retained following surface preparation and recoating, but any showing deep pitting or flaking must be replaced. Welded and bolted clip connections are also suspect and should be renewed where internal rust is observed.

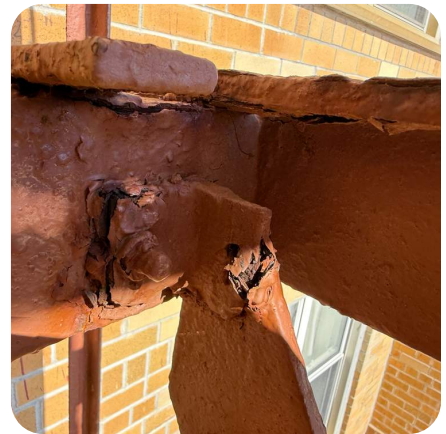
Corroded Stringer connection

Stringer-to-platform clip connections show active corrosion and rust-jacking. Replace all deteriorated angle clips with new **bolted mechanical fasteners** to restore full structural continuity for the staircases.

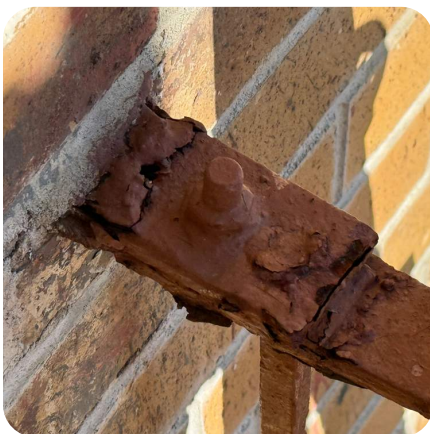
Corroded Railing connection

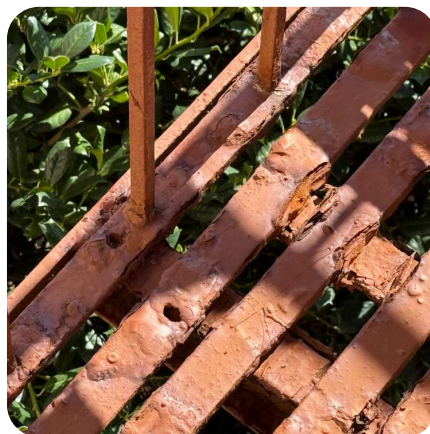
Corroded Platform slats

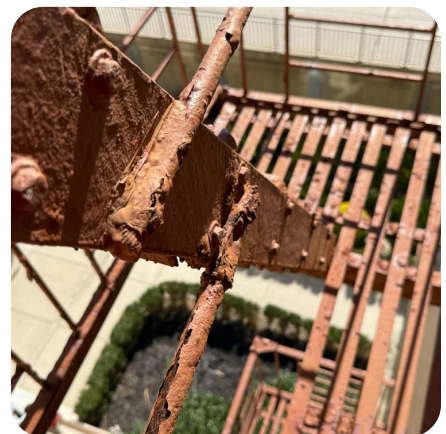
Corroded Railing connection

detached and missing bolts

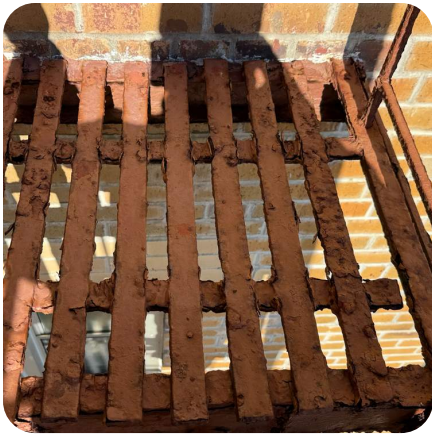
Corroded Platform slats

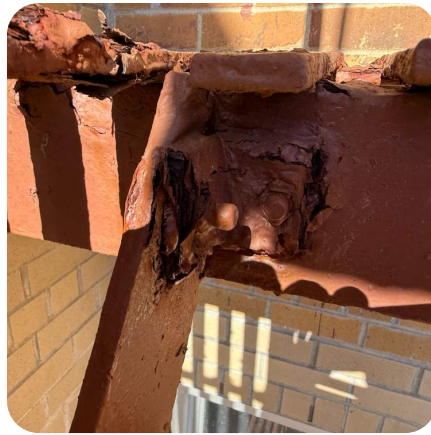
Corroded Stringer connection

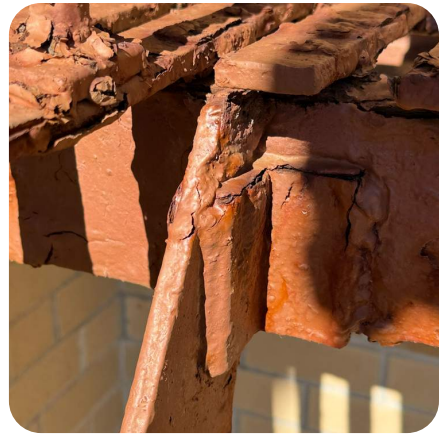
Corroded Stringer connection

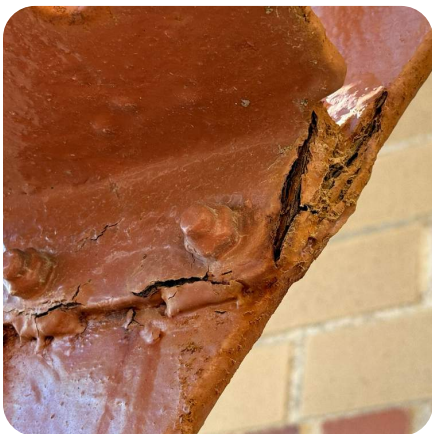
Corroded Tread clip

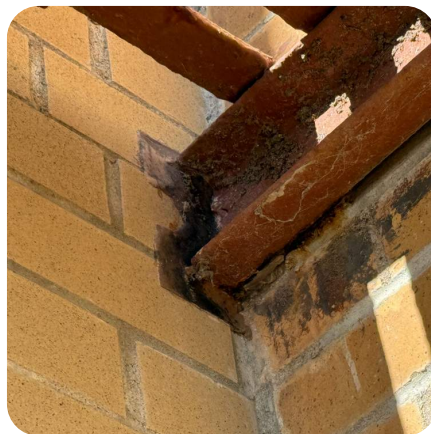
Corroded Support connection

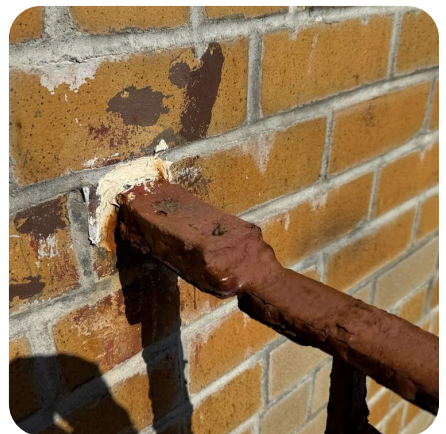
Corroded Railing connection

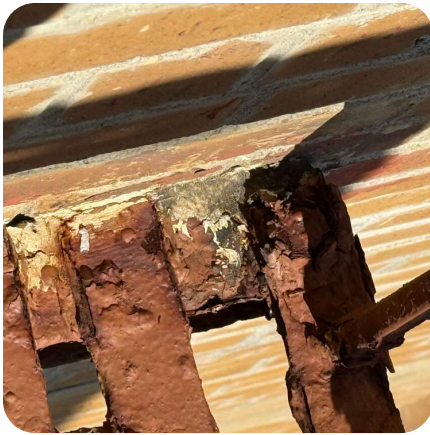
Corroded Platform slats

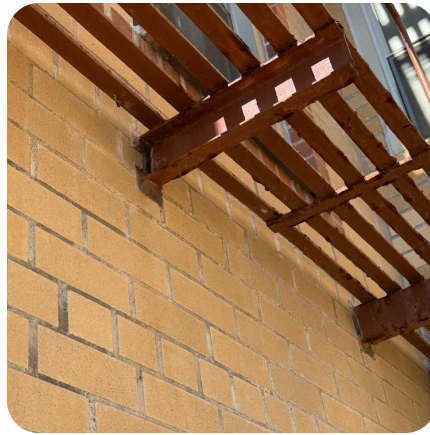
Fair and functional supports,
ready for load testing

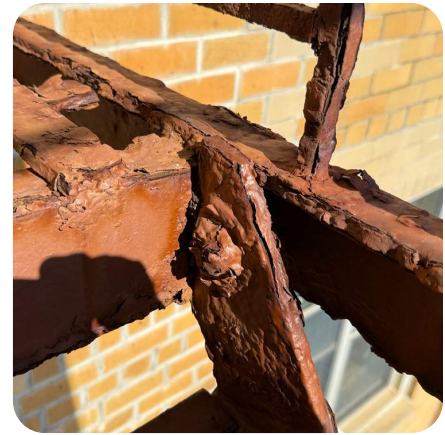
Corroded Stringer
connection

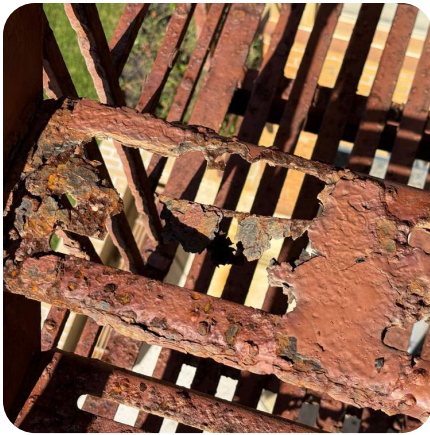
Severely corroded Treads -
Life Safety Concerns &
Imminent Safety Hazards

Treads are **severely distressed and corroded**, with significant section loss resulting in brittleness that may fail under load, posing **serious life-safety hazards** to building occupants and emergency personnel. Some treads are dislodged and suspended by a single clip connection, while others, though appearing fair, show evidence of internal rust within their joints. All compromised treads must be replaced, and remaining units should be cleaned, inspected, and resecured with new **bolted clip connections** to ensure full structural integrity.

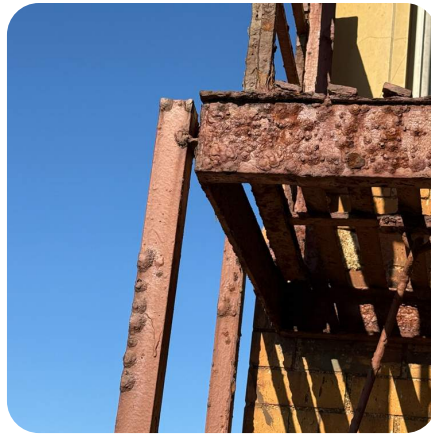
Leg support disconnected
due to severe rust jacking -
Imminent Safety Hazard

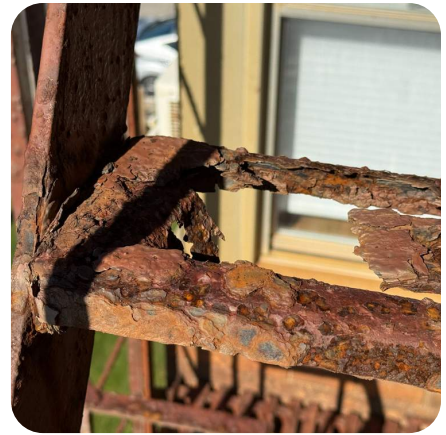
Severely corroded Tread -
Life Safety Concern

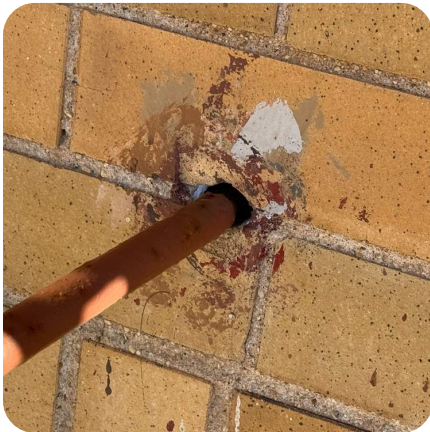
Cement spalling and internal
rust

Embedded C-channels are cantilevered 8–12 inches into the façade and appear generally sound. However, several embedments exhibit cracking and minor section loss at the wall interface. Seal all cracks and joints to prevent further water infiltration.

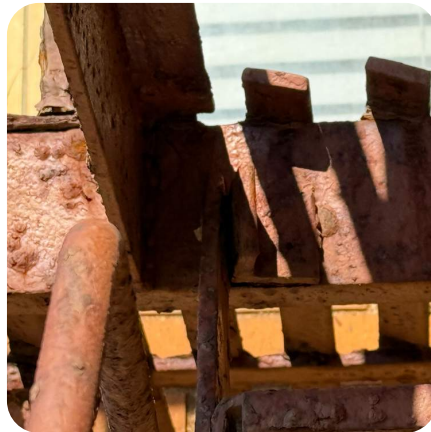
Corroded Platform slats

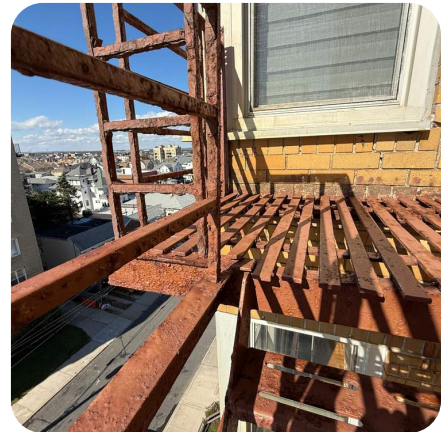
Corroded Railing
connections

Several welded rail joints have corroded and detached. All railing sections require reinforcement or replacement with bolted connections. Staircase railing openings pose a fall hazard; install **three to four ¼-inch stainless-steel safety cables** within the openings to prevent falls.

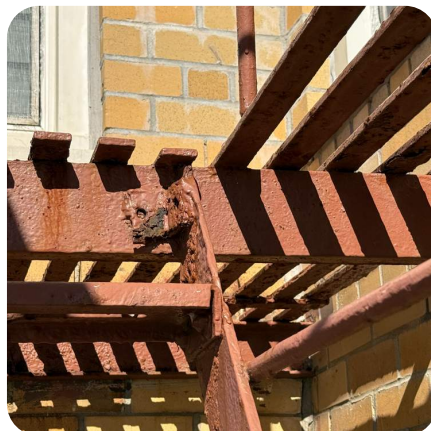
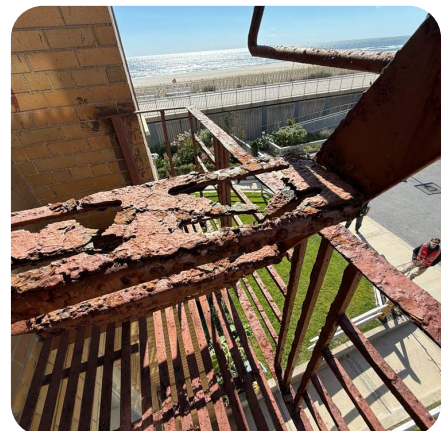
Fair and functional supports,
ready for load testing

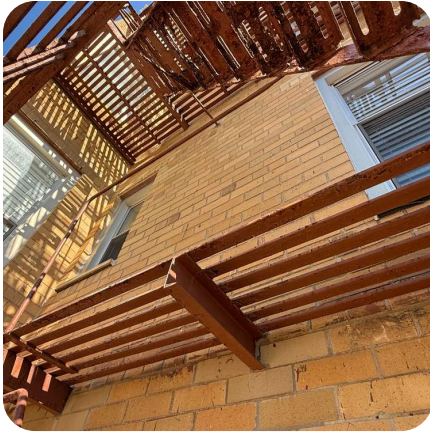
Corroded Stringer
connection

The primary stringers are welded directly to the platform and exhibit only minor surface corrosion. However, additional welded angle clips—previously added as reinforcement—show internal rust and rust-jacking. Several of these clips have deteriorated to the point of detachment and, in some cases, were removable by hand. While the main stringer-to-platform welds currently support the staircase, the loss of these reinforcement clips reduces redundancy and long-term stability. All detached or corroded clips should be replaced and secured with **bolted mechanical fasteners** to restore full structural integrity and prevent future separation.

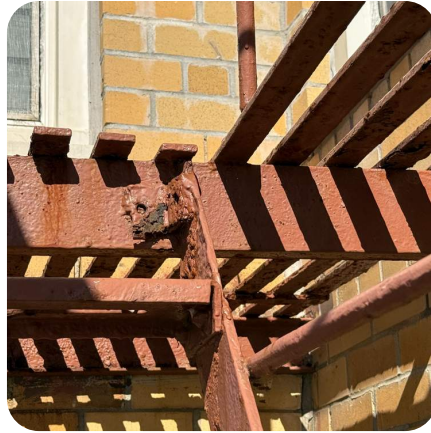
Severely corroded Tread -
Life Safety Concern

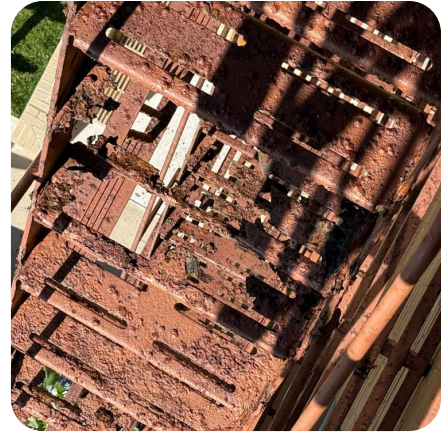
Fair and functional supports,
ready for load testing

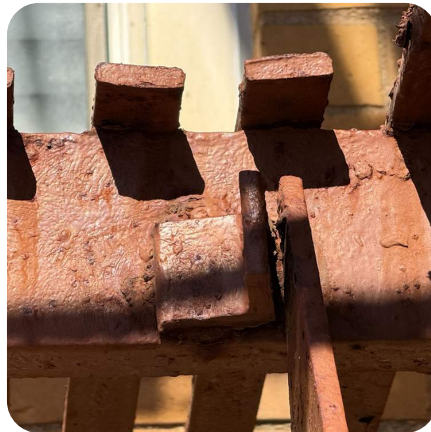
Severely corroded Treads -
Life Safety Concern

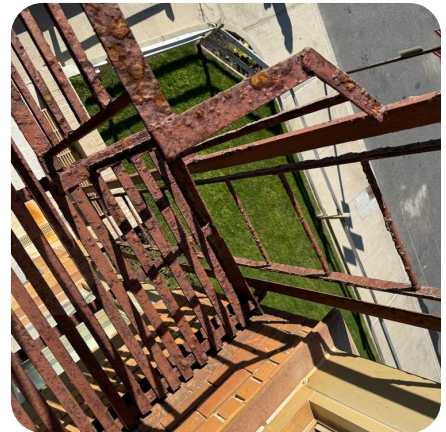
Corroded Platform slats

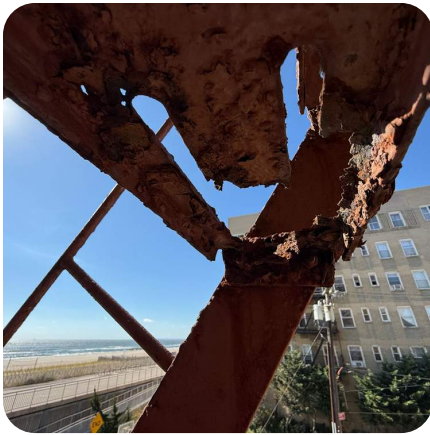
Severely corroded Tread -
Life Safety Concern

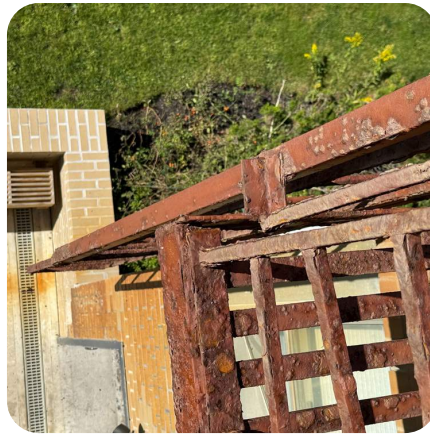
Corroded Ladder
connections

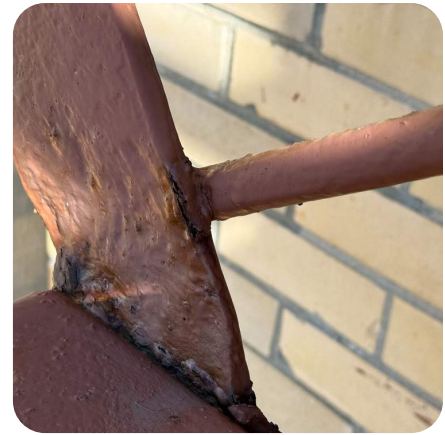
Corroded stringer, railing &
tread connections

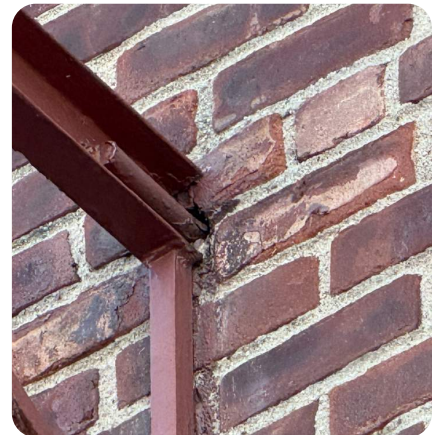
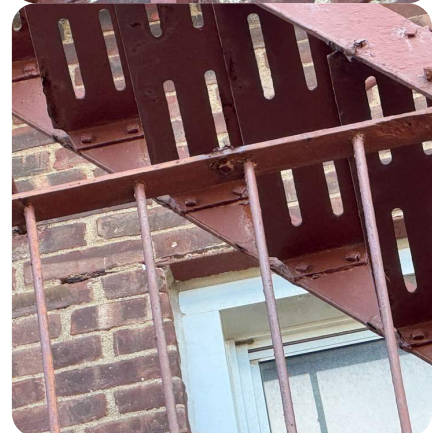
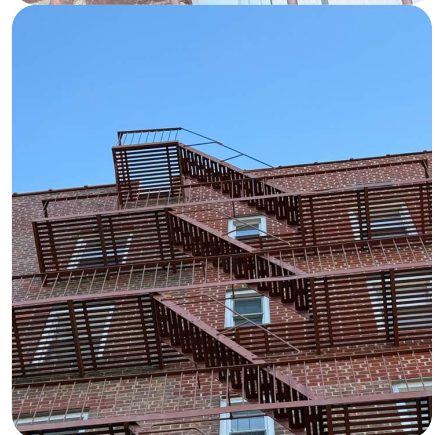
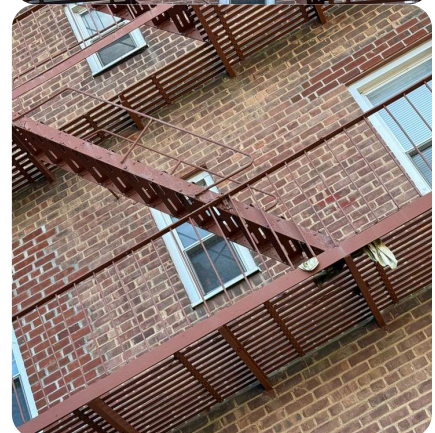
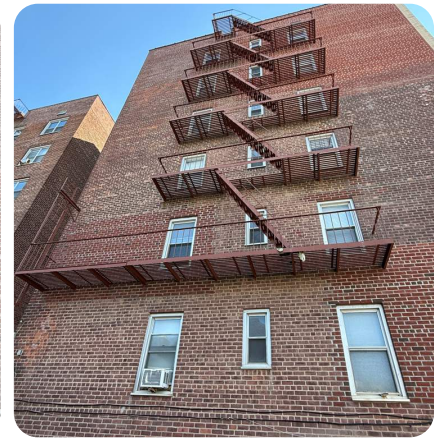
Observed from ground level, the system appears in **fair and functional condition** with moderate surface corrosion and localized minor rust-jacking in contrast to the other front-facing systems due to reduced weather exposure. The structure is presumed serviceable pending close-up verification and load testing.

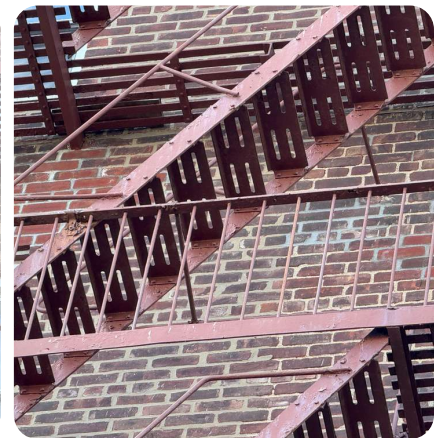
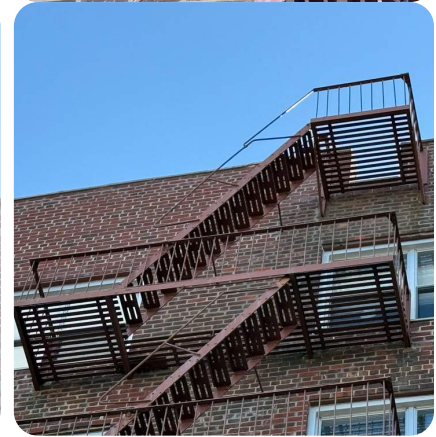
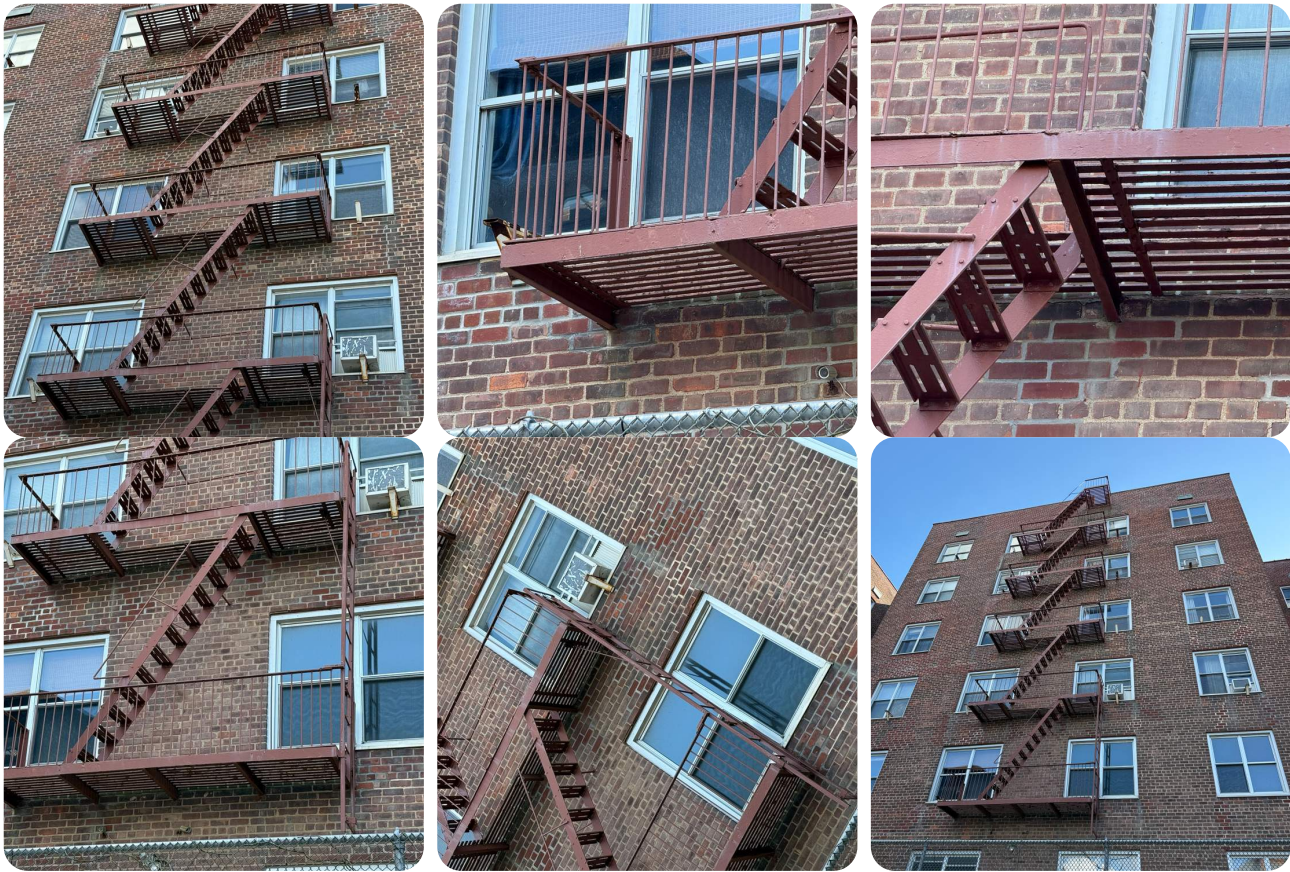
Observed from ground level, the system appears in **fair and functional condition** with moderate surface corrosion and localized minor rust-jacking in contrast to the other front-facing systems due to reduced weather exposure. The structure is presumed serviceable pending close-up verification and load testing.

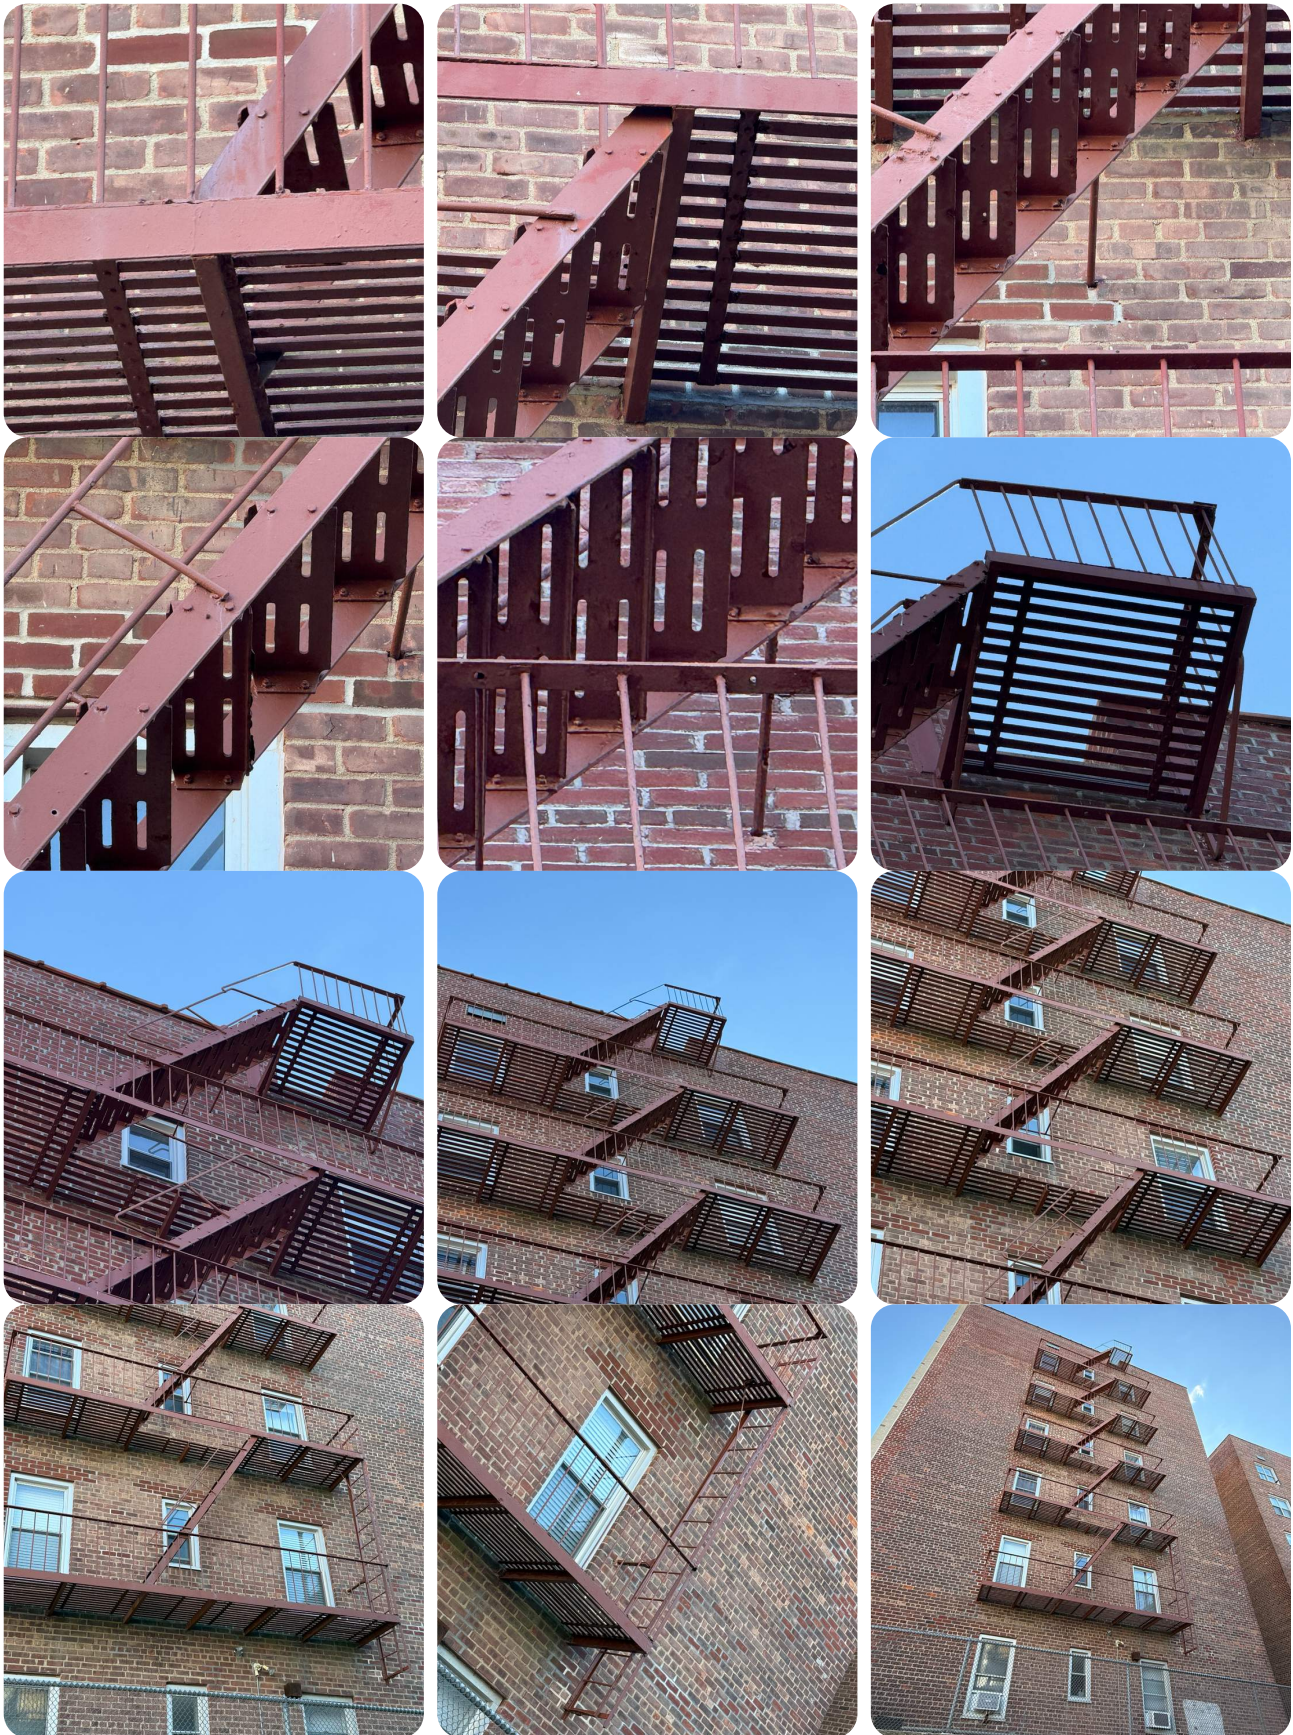
Observed from ground level, the system appears in **fair and functional condition** with moderate surface corrosion and localized minor rust-jacking in contrast to the other front-facing systems due to reduced weather exposure. The structure is presumed serviceable pending close-up verification and load testing.

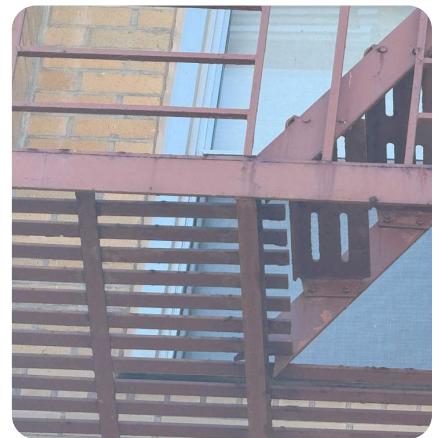
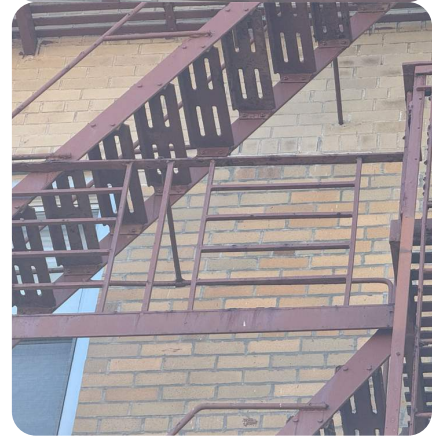
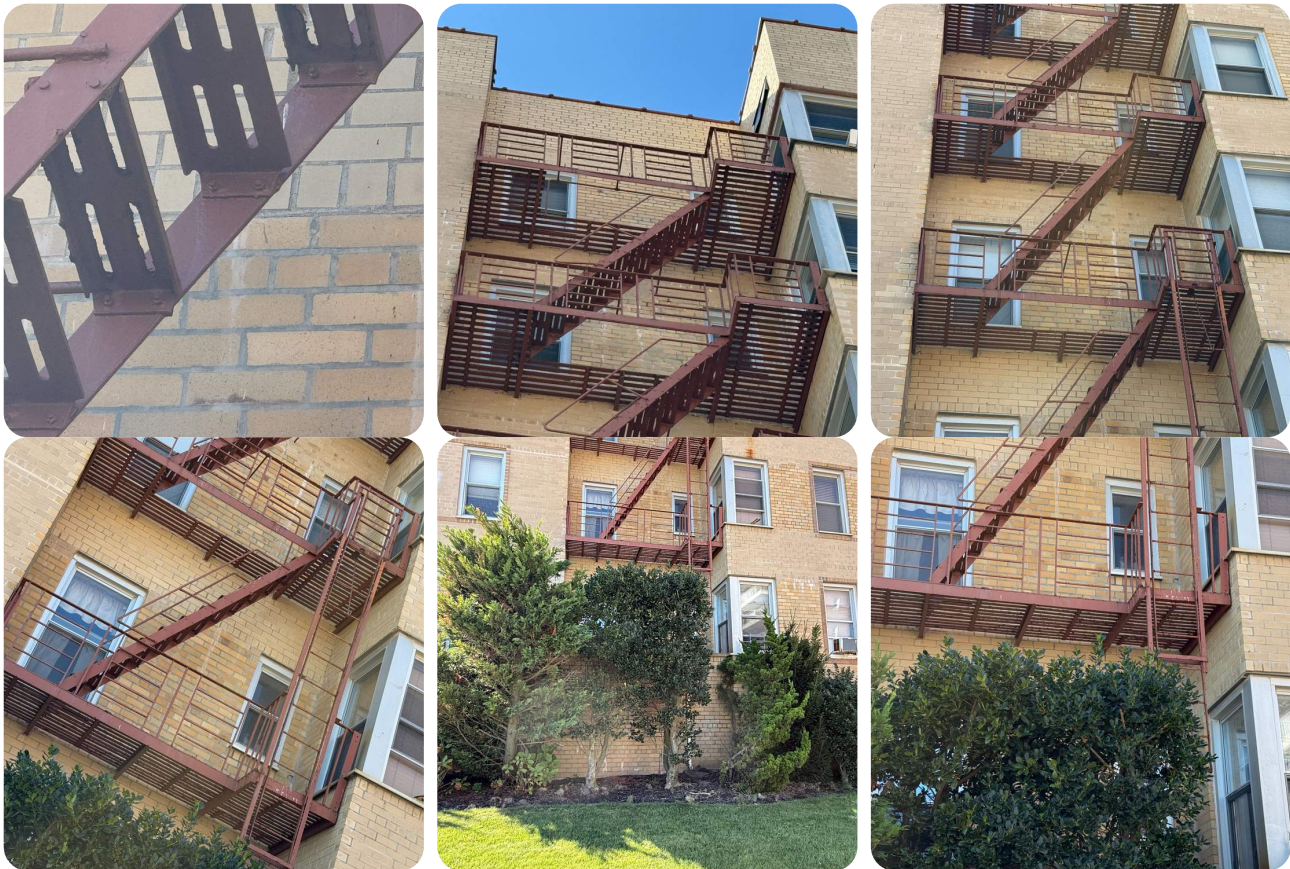
Observed from ground level, the system appears in **fair and functional condition** with moderate surface corrosion and localized minor rust-jacking in contrast to the other front-facing systems due to reduced weather exposure. The structure is presumed serviceable pending close-up verification and load testing.
