# Load Test Report - 999 California St, San Francisco, CA 94108

### 999 California St, San Francisco, CA 94108

The Mark Hopkins Hotel is a 19-story historic landmark atop Nob Hill, featuring a chateau-style design with brick, stone, and ornate terracotta detailing with 5 fire escape egress systems.

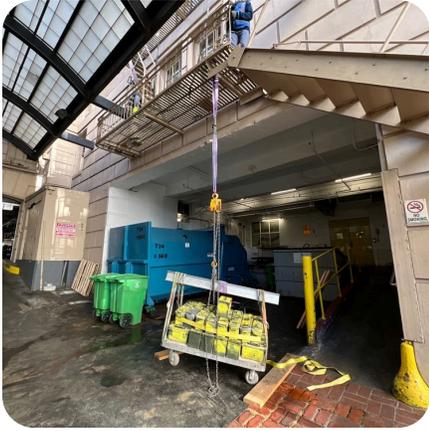
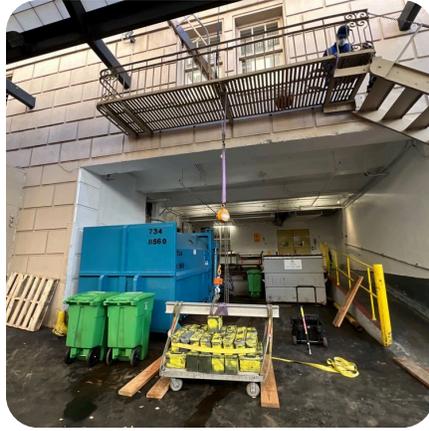
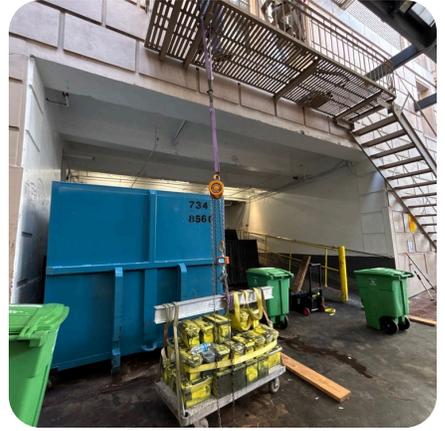
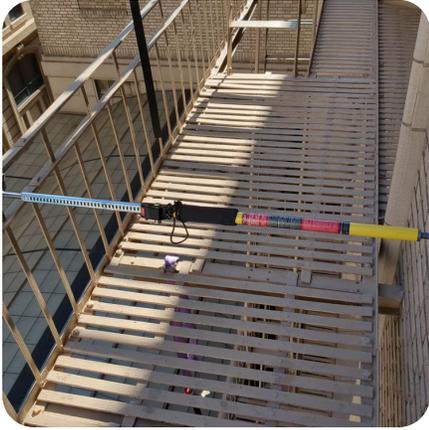
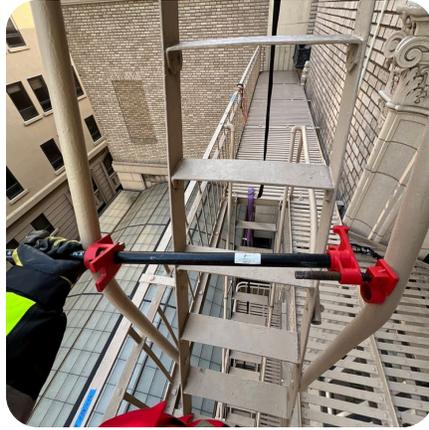
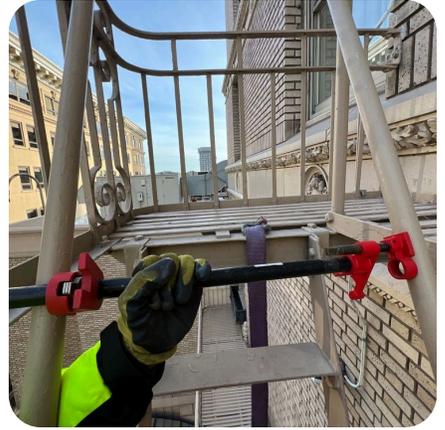
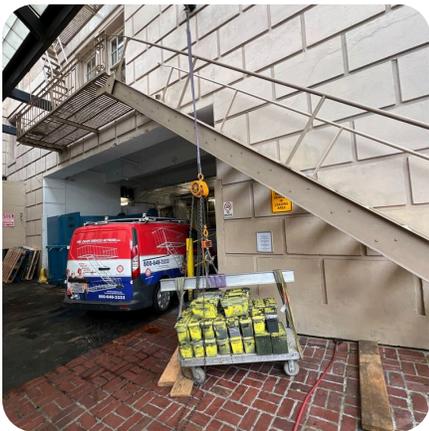
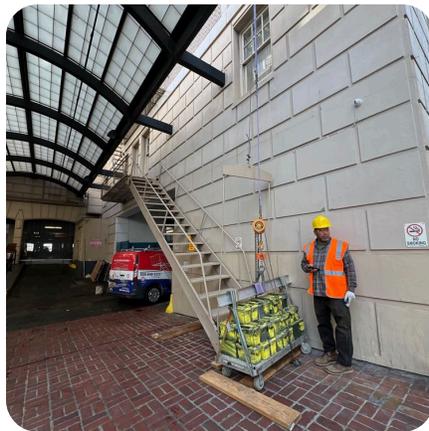
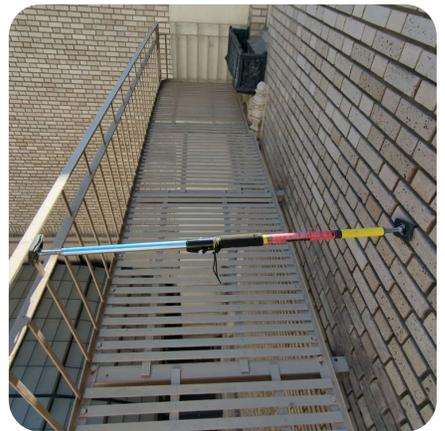
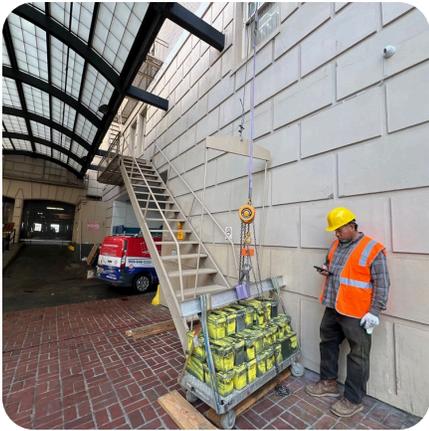
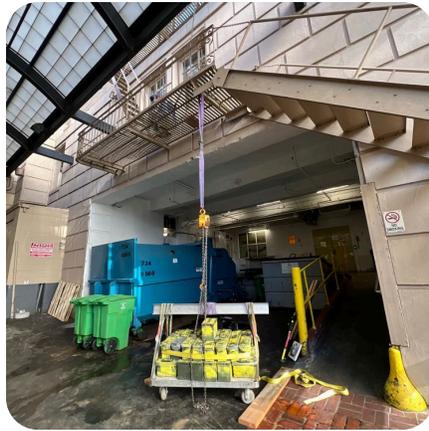
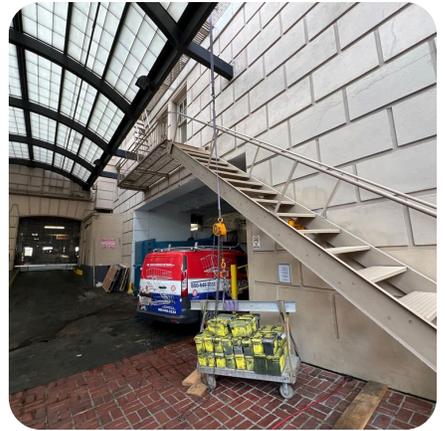
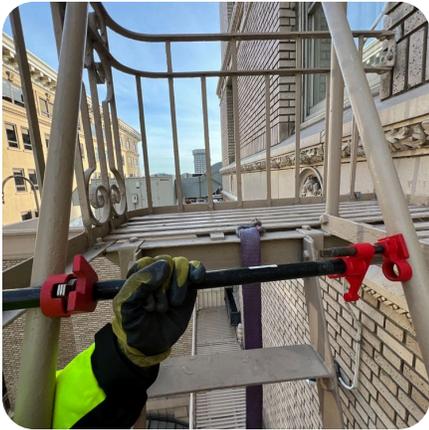
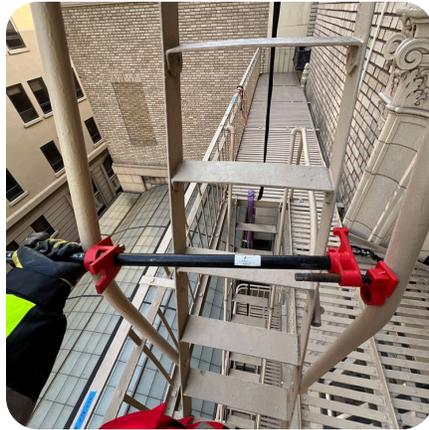
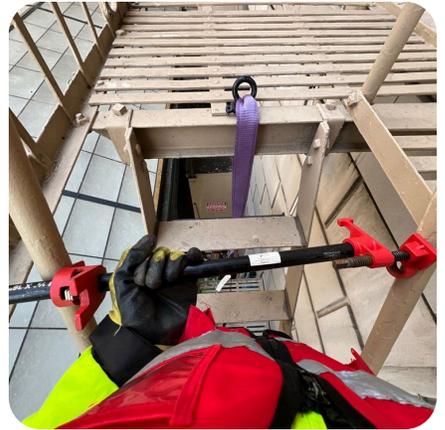
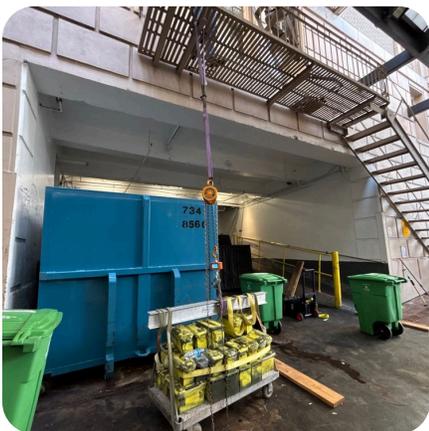
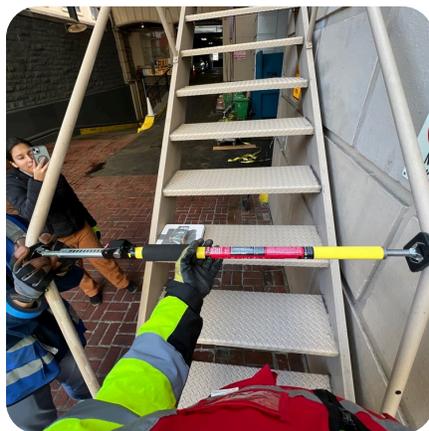
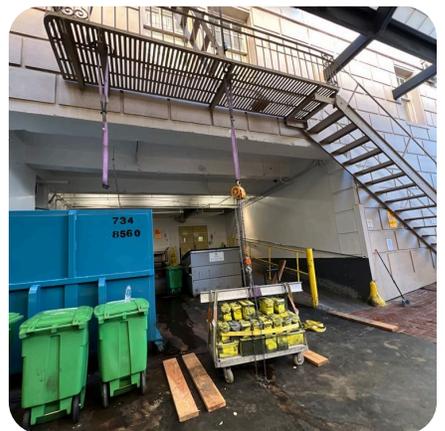
### System (B1): Passed Load Test

System (B1) is made of **galvanized steel** and consists of **platforms** and **inclined ladder** with **counterweight stairs** to grade.

The fire escape system has passed required structural load tests and railing concentrated load tests with minor to negligible deficiencies present. It is recommended to keep the system maintained and painted to prevent deterioration of the material.

The fire escape has successfully passed a live load test of **100 pounds per square foot (psf)** and a **200-pound lateral load test** on the guardrails, in accordance with applicable code requirements.

- Discontinuity observed at platform slats, creating potential trip hazards. Preexisting nonconforming.

Install additional slats to ensure a continuous walking surface and eliminate trip hazards.

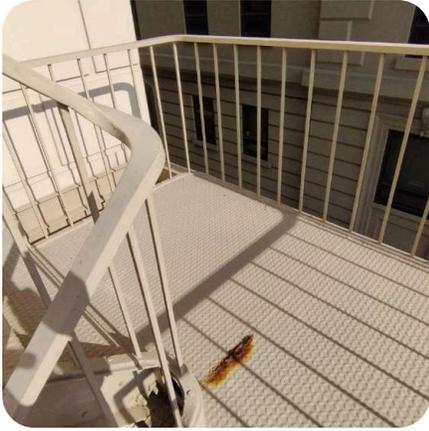
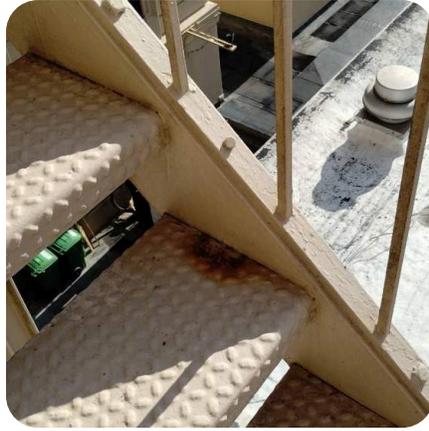
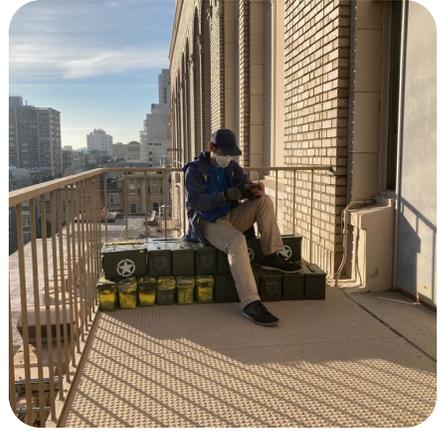
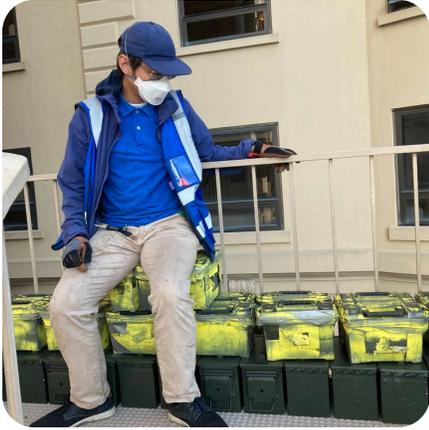
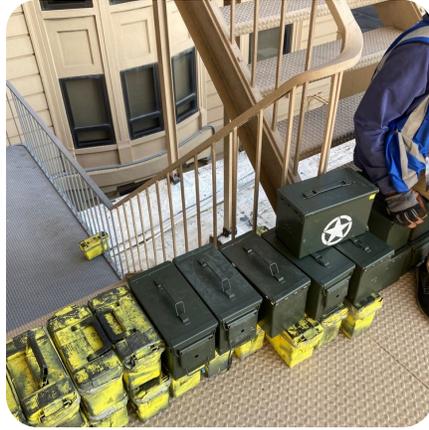
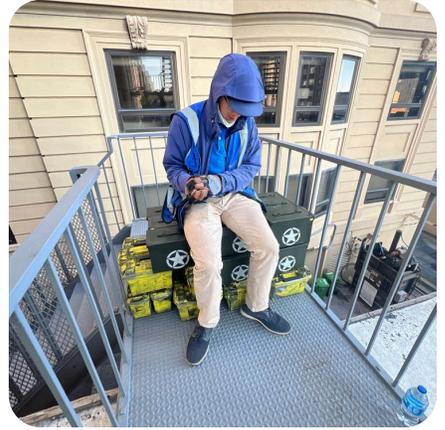
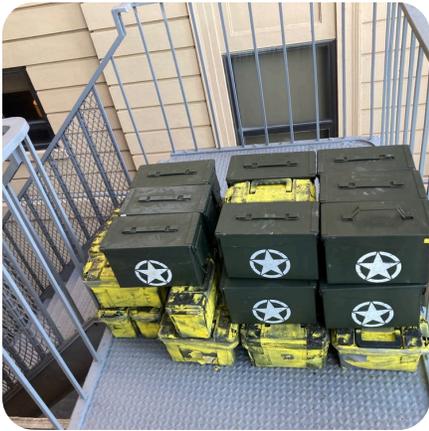
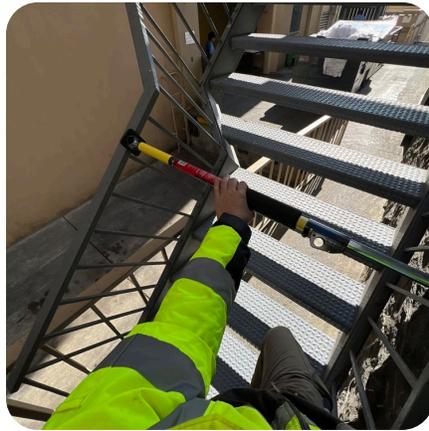
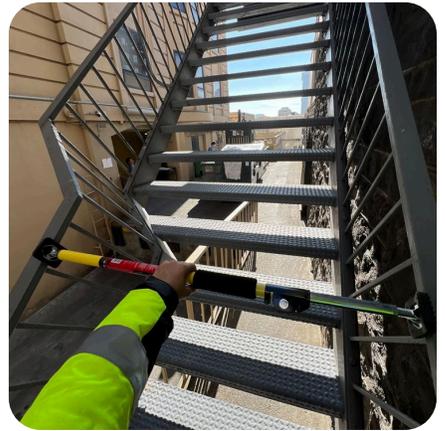
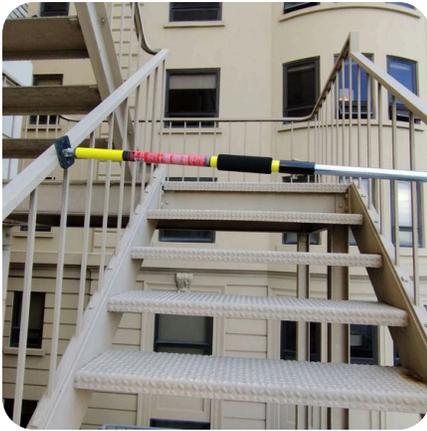
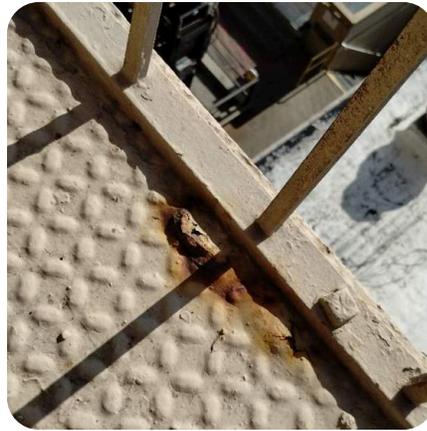
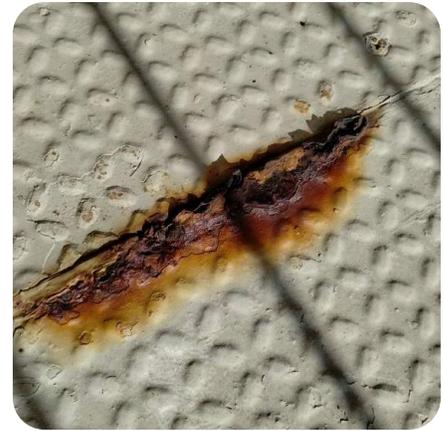
## System (C1-B2): Passed Load Test

The visual inspection has revealed multiple areas of **localized deterioration** primarily due to **corrosion and moisture infiltration**.

Water intrusion is causing rust jacking, corrosion, and material loss of material at some seams at tread-to-stringer and diamond plate to diamond plate connections.

Timely corrective action, including cleaning and proper priming and painting to protect against the elements is strongly recommended to maintain the fire escape's safety, functionality, and code compliance.

Corrective Action: Cleaning, treatment and paint of corrosion-affected sites to limit further exposure to water and rusting.

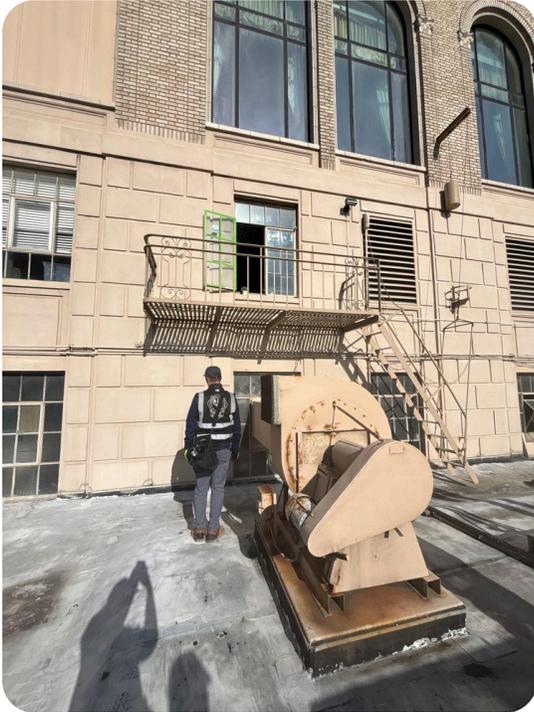
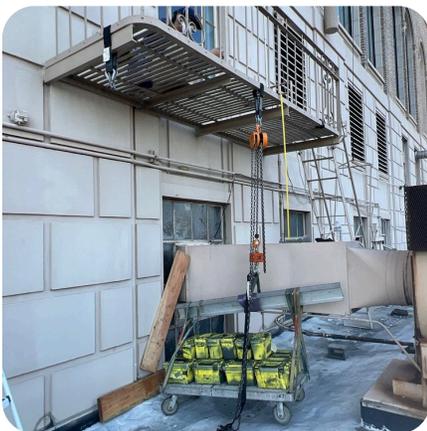
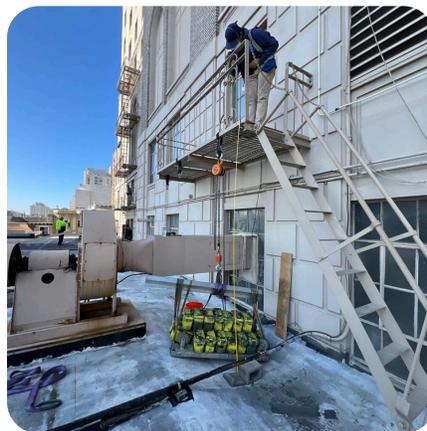
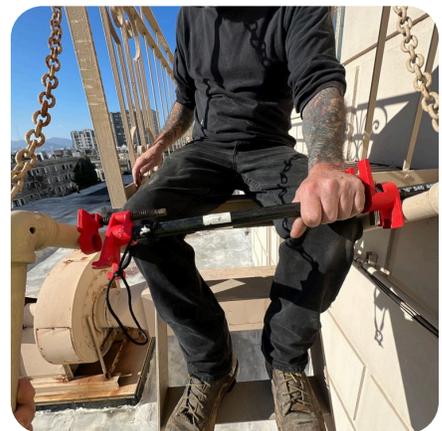
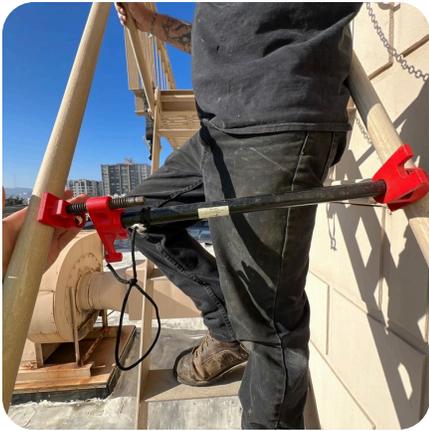
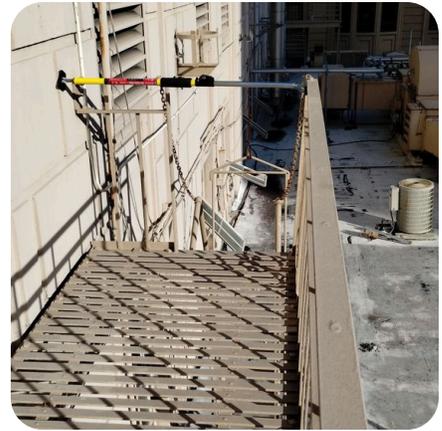
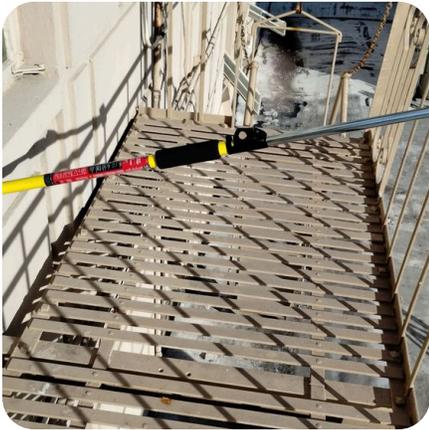
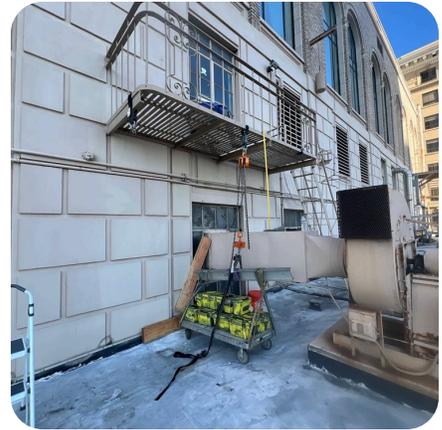
## System (C2): Passed Load Test

The fire escape system has passed required structural load tests without deficiencies. The paint is in fair condition. The counterweight stairs system has been found to be left in a down position, and exhibits minor signs of deterioration, including discolored (brown) cables indicative of insufficient maintenance, as well as corrosion on the pulley discs and the counterweight box.

In addition to load testing, a **visual evaluation** was conducted. During this evaluation, negligible deficiencies that did not prevent the system from passing were identified. System is recommended to be kept painted. Counterweight system should be greased if it is not intended for the inclined ladder to be kept permanently down.

Timely corrective action, including painting and maintenance, is strongly recommended to maintain the fire escape's safety, functionality, and code compliance, especially if the stairs is brought back to an up-position..

Recommend to grease and maintain counterweight stairs, such that it can be brought to an up-position as needed.

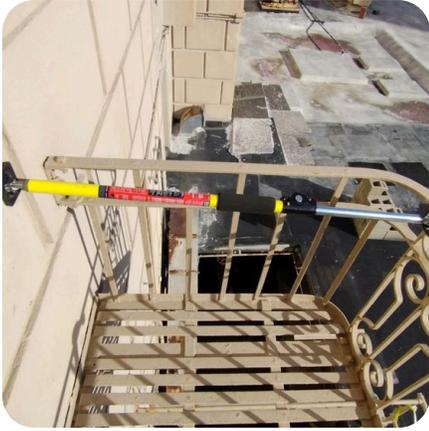
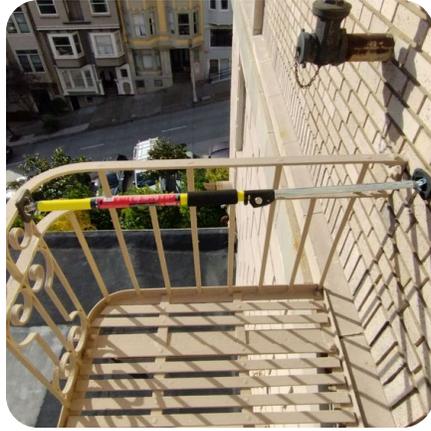
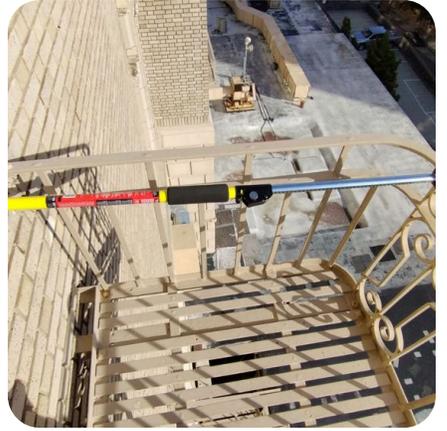
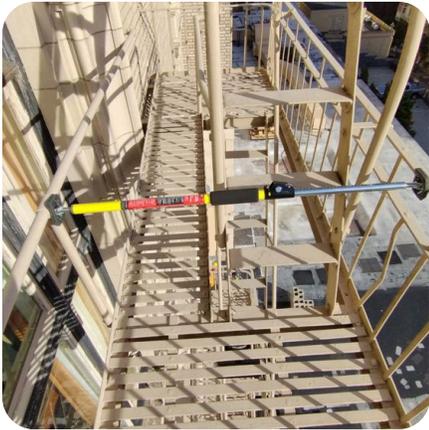
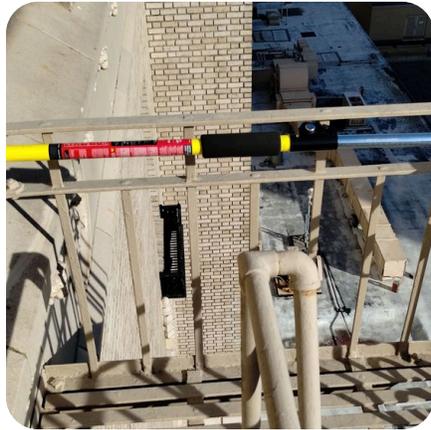
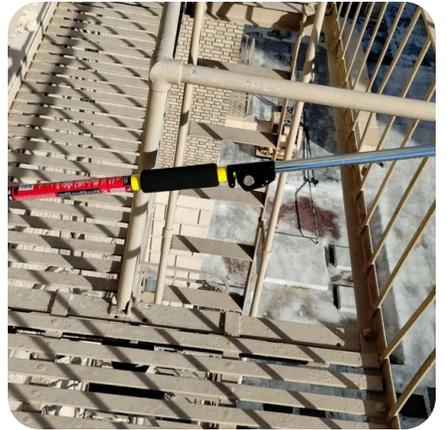
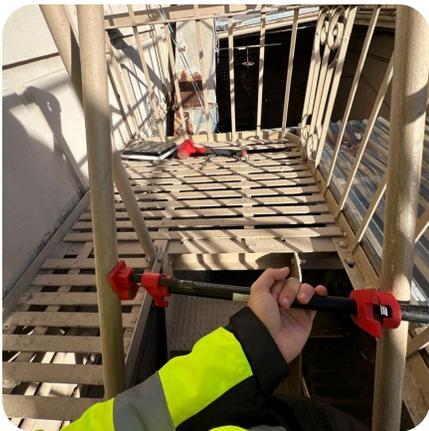
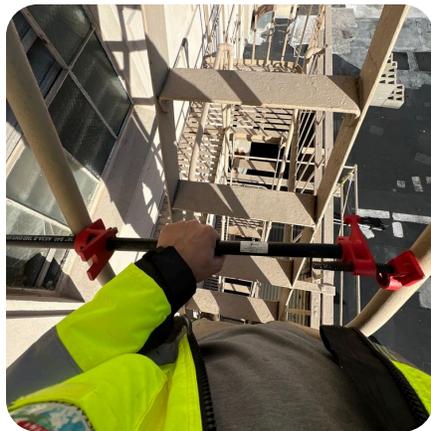
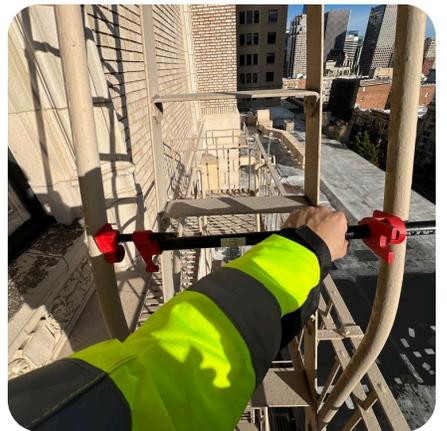
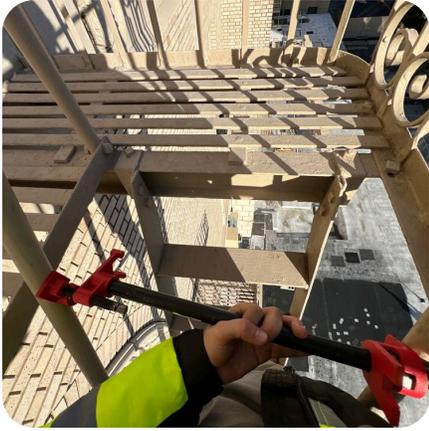
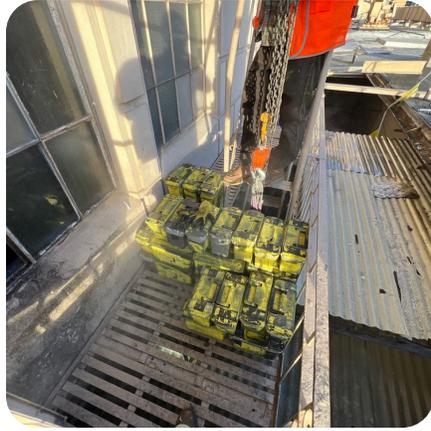
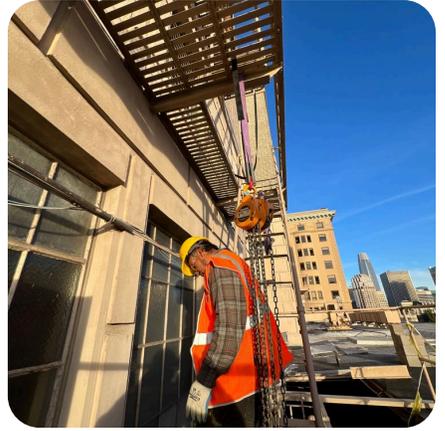
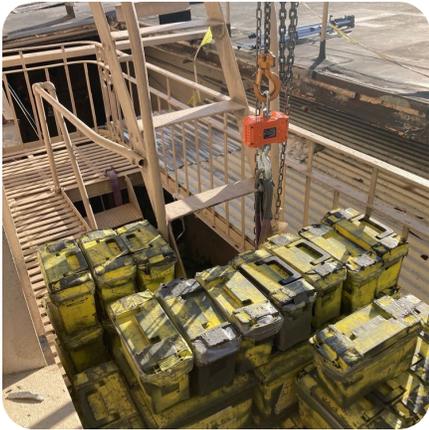
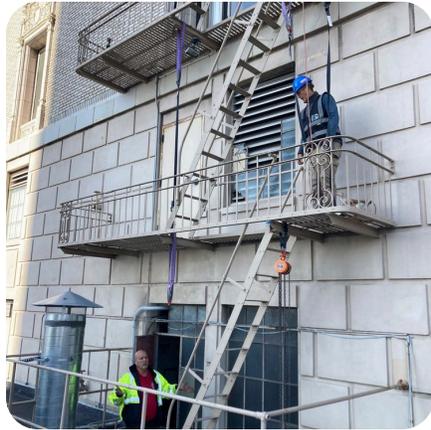
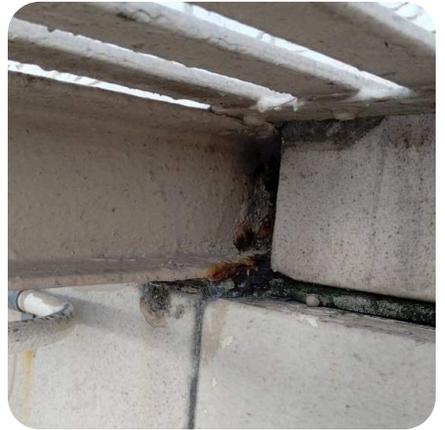
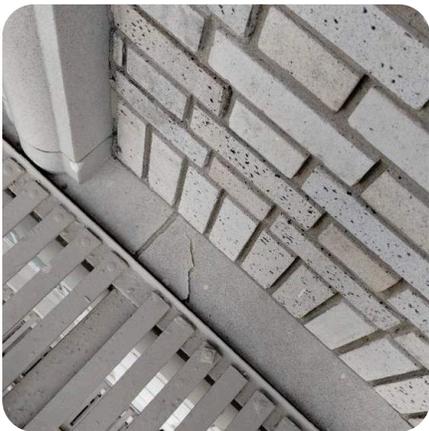
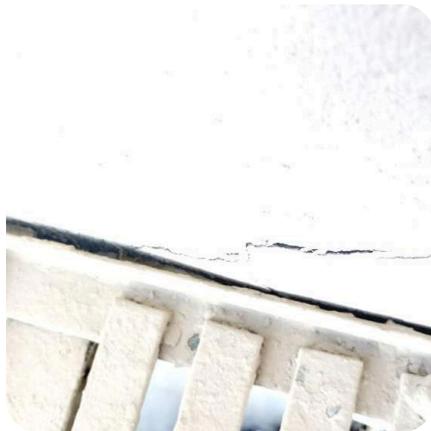
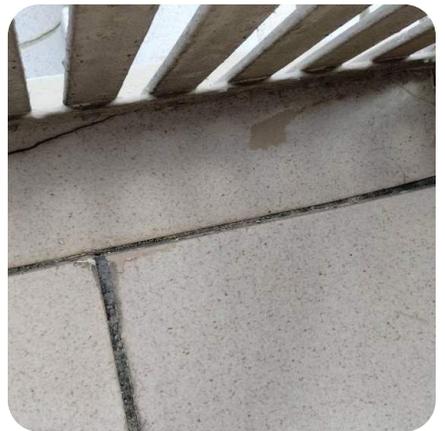
## System (C3): Passed Load Test

The visual inspection has revealed a few areas of localized surface deterioration primarily due to corrosion and moisture exposure, mainly from steam exhaust exposure.

Cracks are noted to be present at or near some support connection to the wall, which may allow water intrusion if not sealed. One support has corrosion at connection to the wall, which may cause mechanical damage and further deterioration if not addressed, cleaned, and painted.

A steam vent is noted to keep lower parts of the system moist; those parts must be kept painted and maintained against exposure and accelerated corrosion.

Timely corrective action, including cleaning and proper priming and painting to protect against the elements is strongly recommended to maintain the fire escape's safety, functionality, and code compliance.

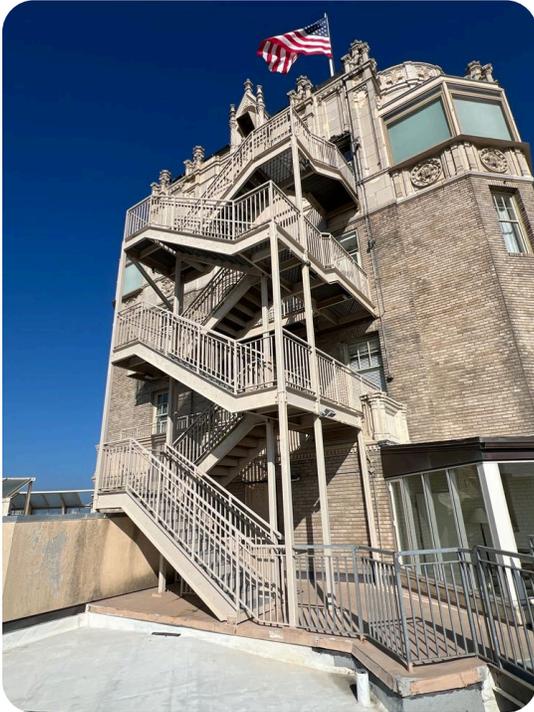
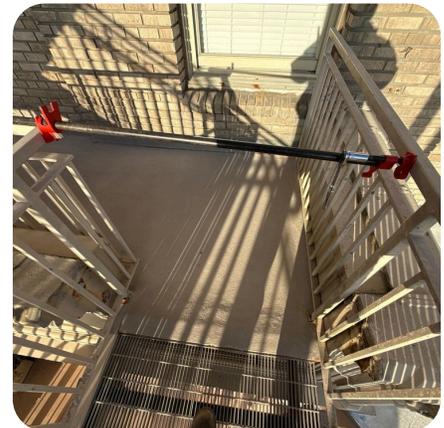
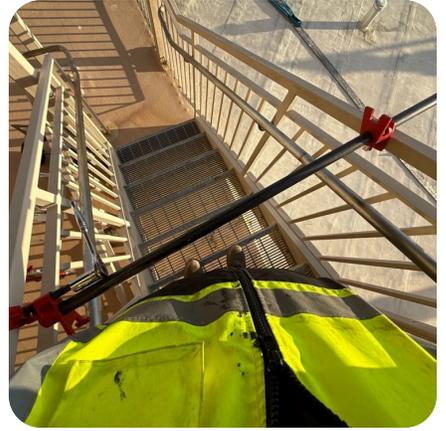
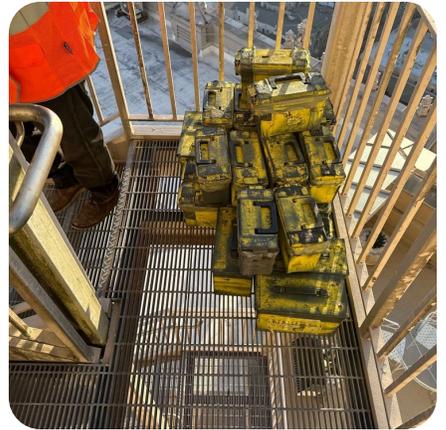
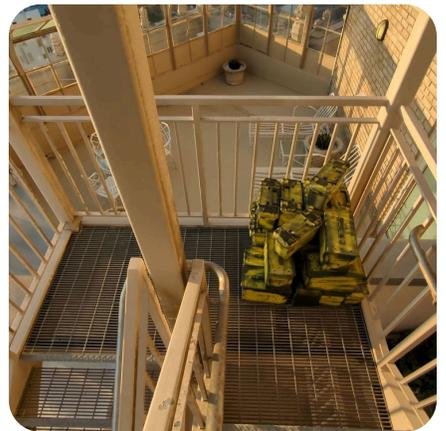
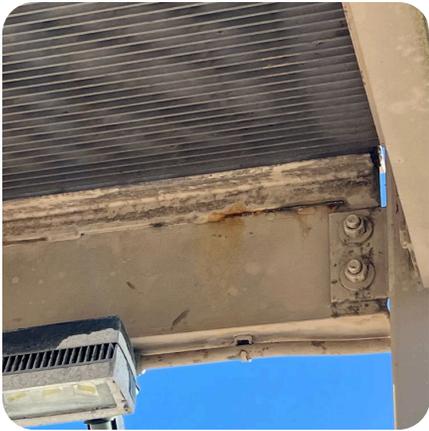
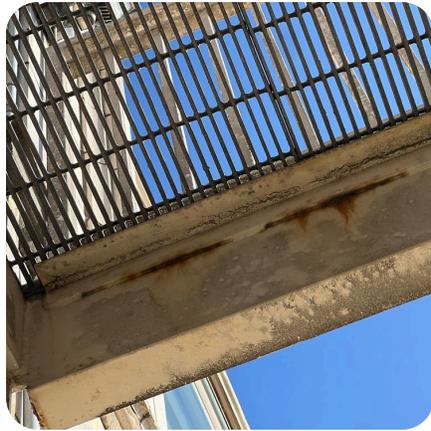
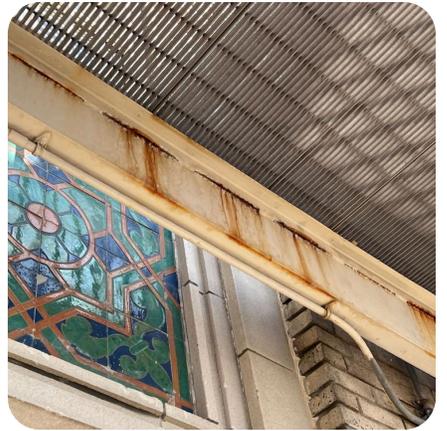
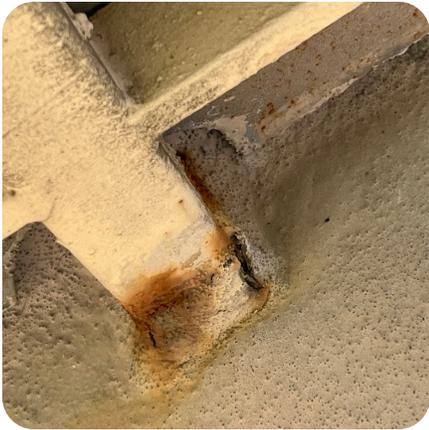
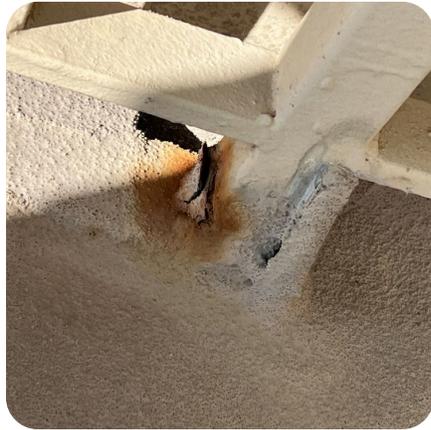
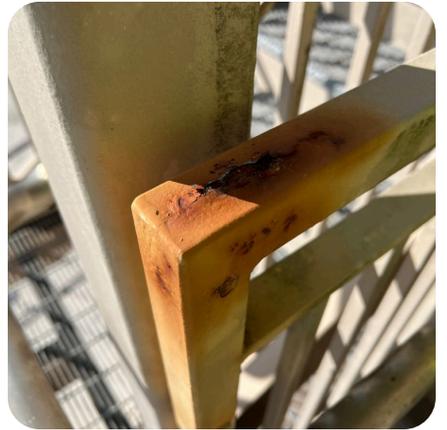
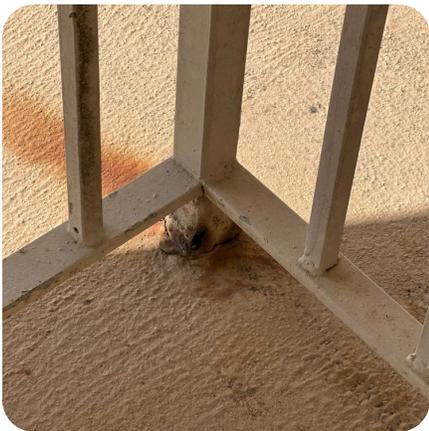
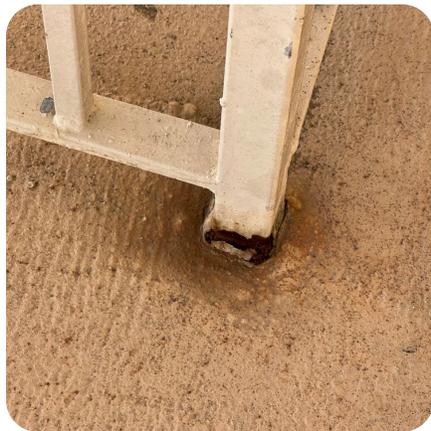
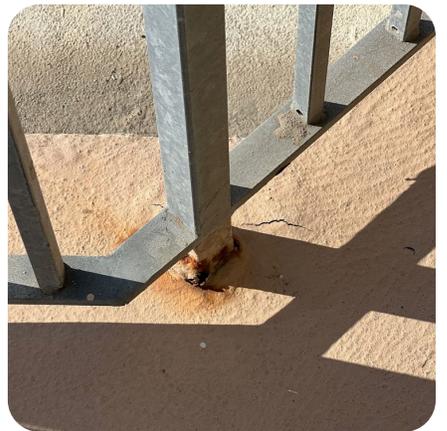
## System (D1): Deficiencies Present

While the fire escape system has passed required structural load tests at most locations, the visual inspection has revealed multiple areas of **localized deterioration** primarily due to **corrosion and moisture infiltration**, especially at welded joints at platform shelf angles that support the grating and at some railing tube posts.

Platform shelf: Internal rust is present at platform shelf angle welded connections to platform frame. Welds have currently passed load test, but will continue to degrade and deteriorate over time as rust expands. Shelf angles should be bolted to reinforce and negate rusting connections.

Some tube railings have severed at the connection to frame due to material loss at base from rust and water intrusion. These do not pass the 200 pound lateral load test.

Timely corrective action, including painting, sealing, bolt replacement, and concrete repair, is required to maintain the fire escape's safety, functionality, and code compliance.

Welded platform shelf angles supporting the grating pass load test, but have rust jacking in the connection to platform frame. To preserve integrity of the welds, rust should be removed, and the exposed metal treated, painted, and sealed against further rust and water intrusion. Other sections of metal have surface rusting, and should be properly painted to preserve lifetime of the components.
