## PRE-LOAD TEST EVALUATION RESULTS

PERFORMED AT: **C**  
side  
**720 Ocean Ave Ocean City NJ**

INSPECTION DATE **September 3 2026**  
REPORT DATE **September 9 2026**  
REPORT EXPIRES **December 9 2026**

## PRE-LOAD TEST INITIAL EVALUATION PASS/FAIL REPORT

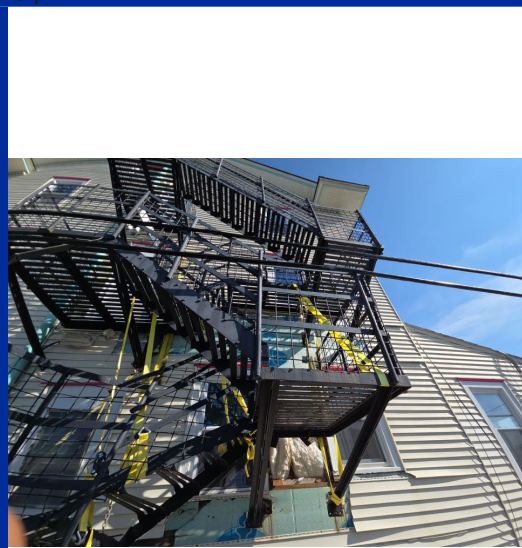
### 1. Overall Structural:

**Life Safety (LS)**

75-100%

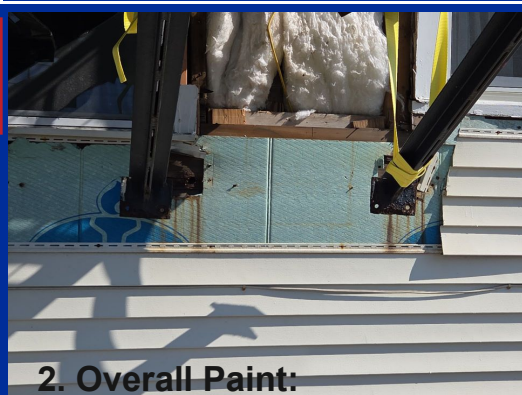
### 2. Overall Paint:

**Poor/Fail**

50-75%

Overall the paint Fail: Spot paint on system required after repairs. Recommend to power wash and seal all major joints to prevent water intrusion into structural connections. Fire Escapes, must be maintained/ painted every 5-7 years as per manufactures recommendation.

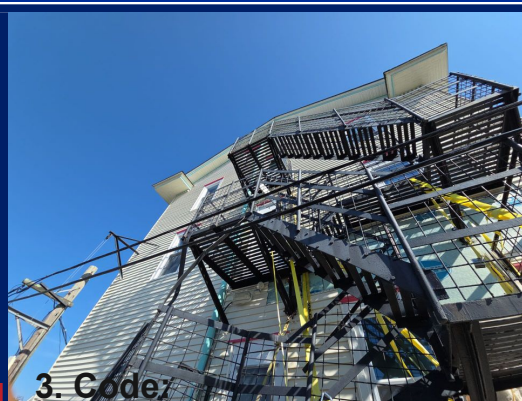
### 3. Code:

50%

Our inspector found some code issues related to AHJ (Authority Having Jurisdiction) or PENC (pre-existing non-conforming) requirements for this Fire Escape system.

Power lines run less than 10 ft from the second platform railings and interfere with the counterweight mechanism, creating a potential safety hazard.
