Pre-Load Test Evaluation Report -

Pre-Load Test Evaluation by Fire Escape Engineers

Evaluation Date: 10/22/2025

Building Description: 6-story brick structure with 7 system(s) on the building.

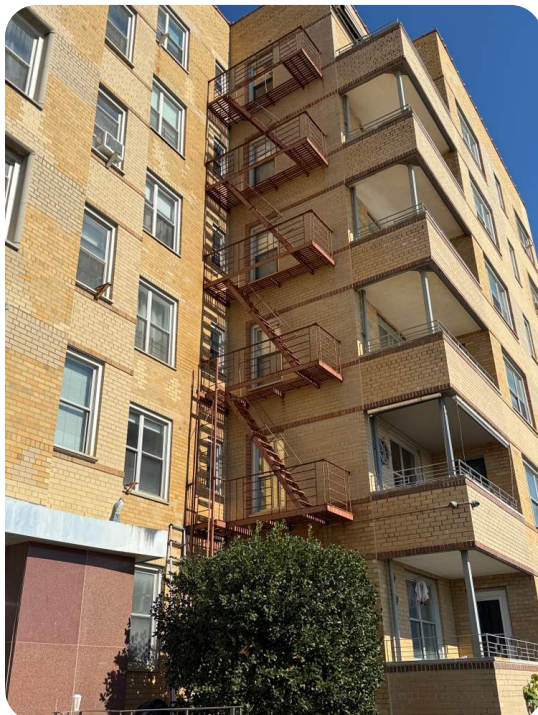
System (A1)

is made of painted steel and consists of platforms and stairs with drop ladder to grade.

Results: Fail Major

Life Safety Concerns on *broken and missing treads*

Imminent Safety Hazards on **treads** with *severe material loss*

Supports, stringers, platforms and railings have suspect connections with internal rust, rust jacking, and some material loss.

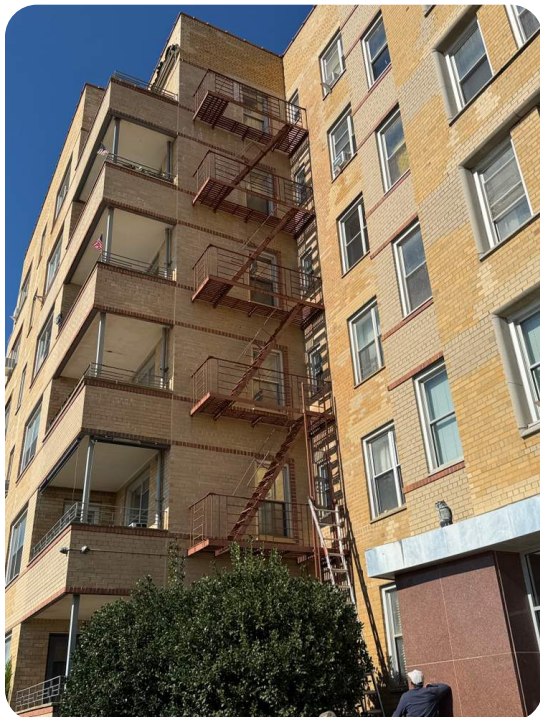
System (A2)

is made of painted steel and consists of platforms and stairs with drop ladder to grade.

Results: Fail Major

Imminent Safety Hazard concerns on railings and treads with *rust jacking and material loss*.

Supports, stringers, platforms and railings have suspect connections with internal rust, rust jacking, and some material loss.

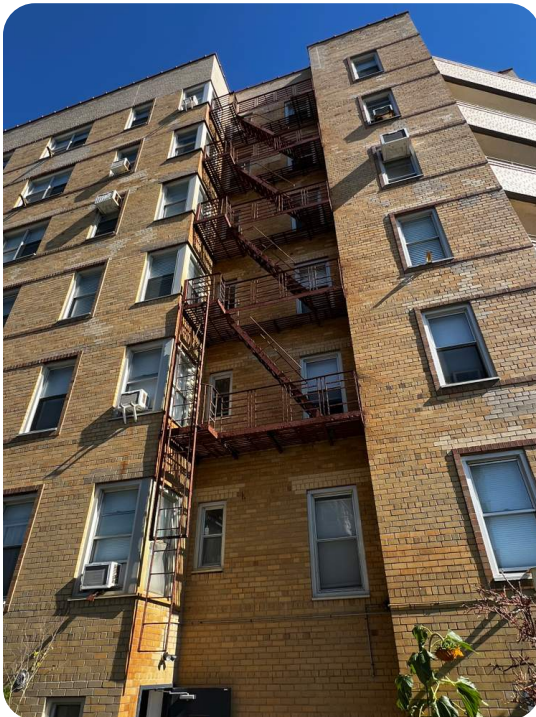
System (B)

is made of painted steel and consists of platforms and stairs with drop ladder to grade.

Results: Fail Major

Life Safety Concerns on *broken and missing treads*

Imminent Safety Hazards on **treads** *with severe material loss*

Supports, stringers, platforms and railings have suspect connections with internal rust, rust jacking, and some material loss.

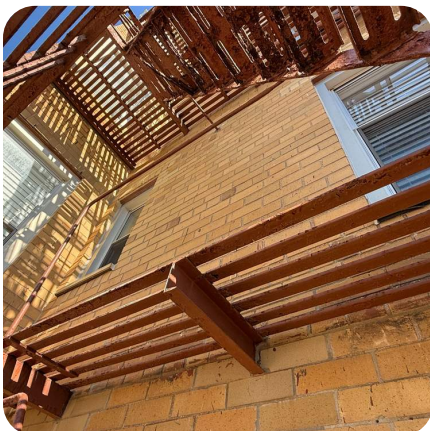
Fair and functional supports,
ready for load testing

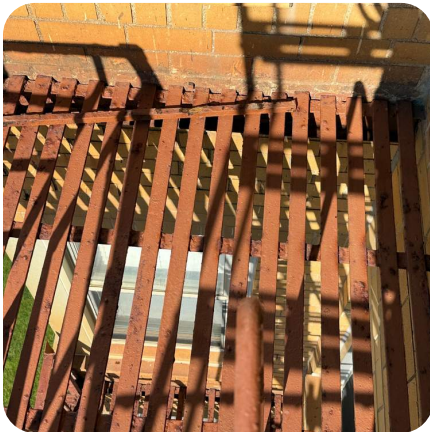
Corroded Stringer
connection

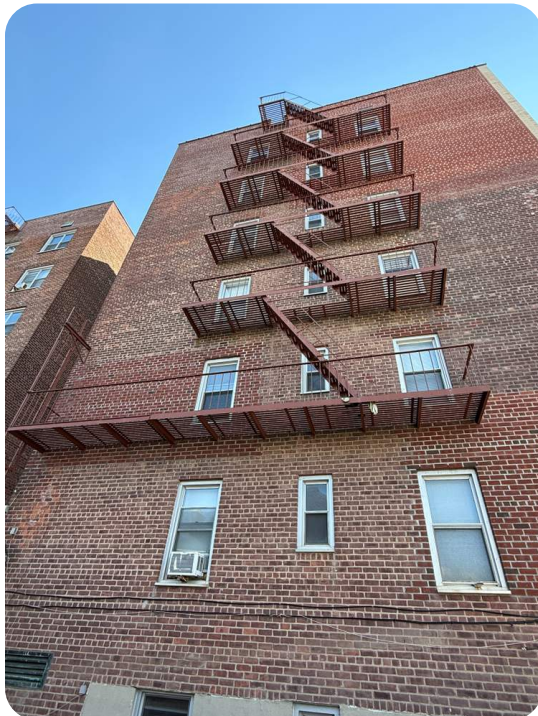
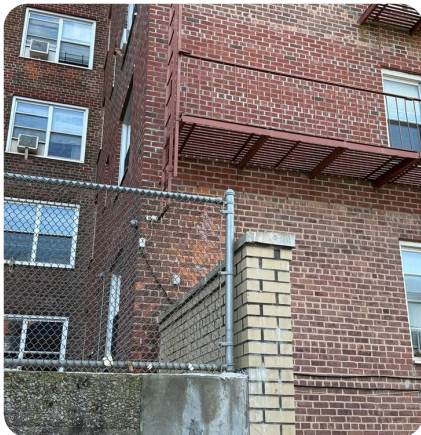
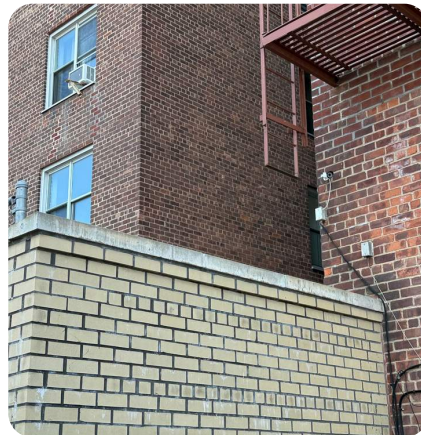
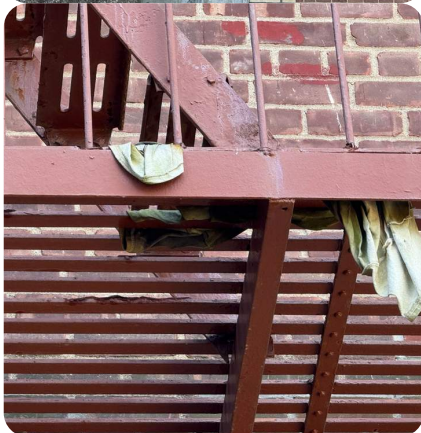
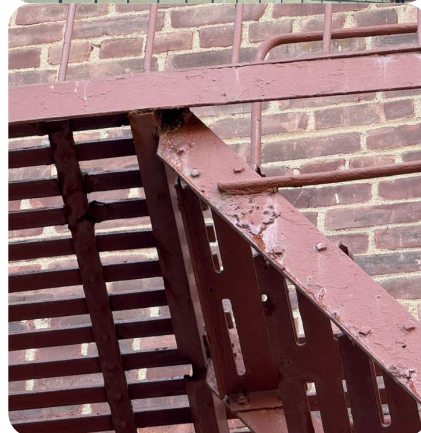
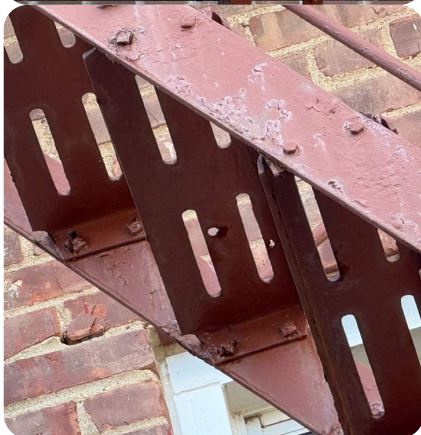
System (C1)

Results: Ready for Load Test with Deficiency Report

Observed from ground level, the system appears in **fair and functional condition** with moderate surface corrosion and localized minor rust-jacking in contrast to the other front-facing systems due to reduced weather exposure. The structure is presumed serviceable pending close-up verification and load testing.

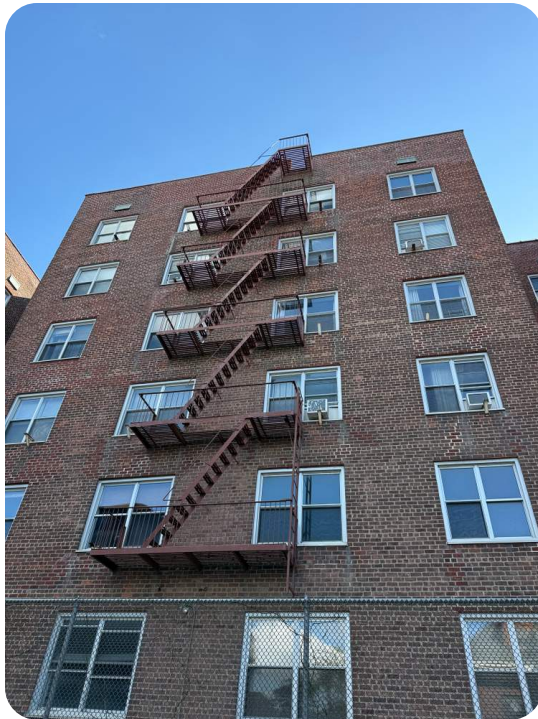
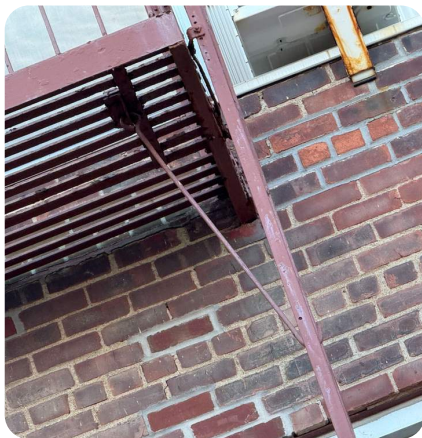
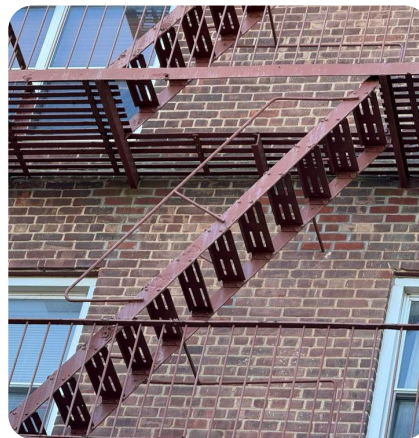
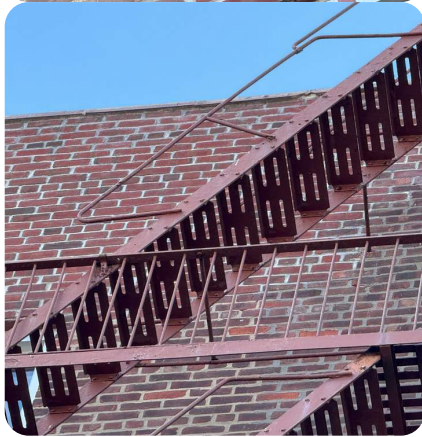
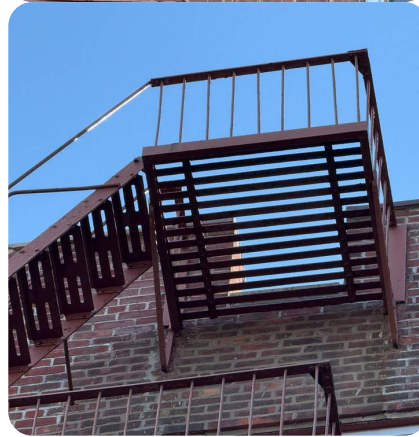
System (C2)

Results: Ready for Load Test with Deficiency Report

Observed from ground level, the system appears in **fair and functional condition** with moderate surface corrosion and localized minor rust-jacking in contrast to the other front-facing systems due to reduced weather exposure. The structure is presumed serviceable pending close-up verification and load testing.

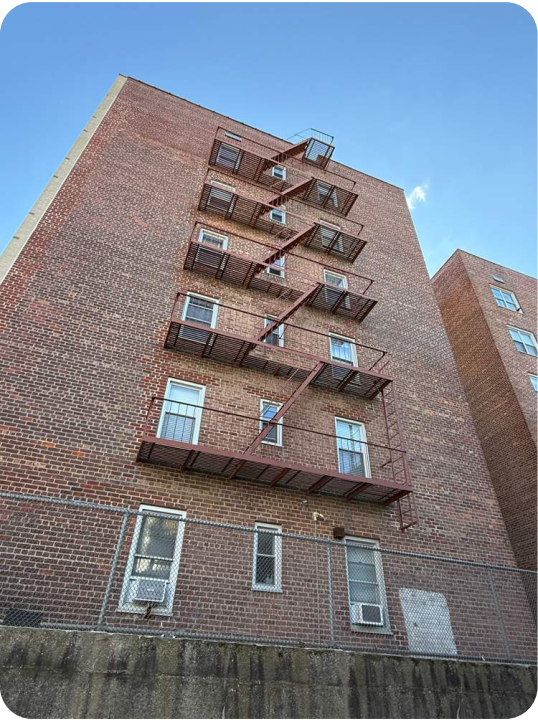
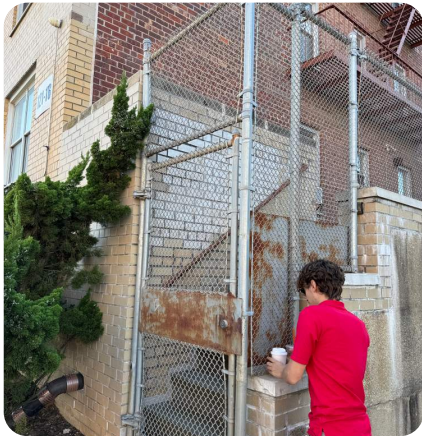
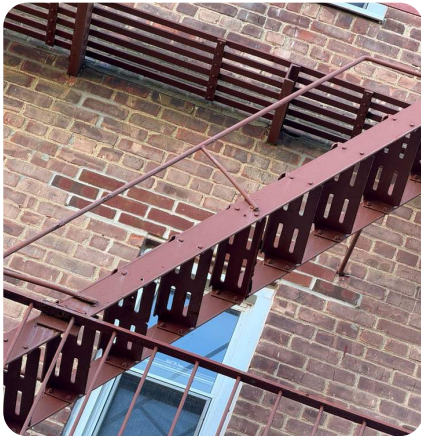
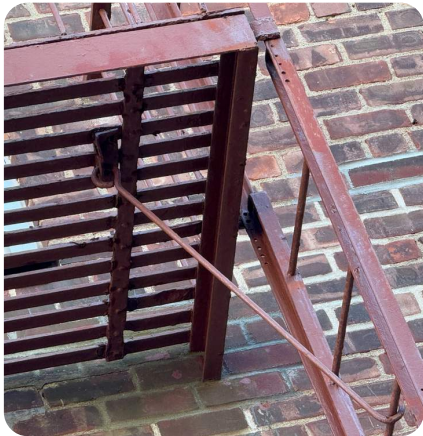
System (C3)

Results: Ready for Load Test with Deficiency Report

Observed from ground level, the system appears in **fair and functional condition** with moderate surface corrosion and localized minor rust-jacking in contrast to the other front-facing systems due to reduced weather exposure. The structure is presumed serviceable pending close-up verification and load testing.

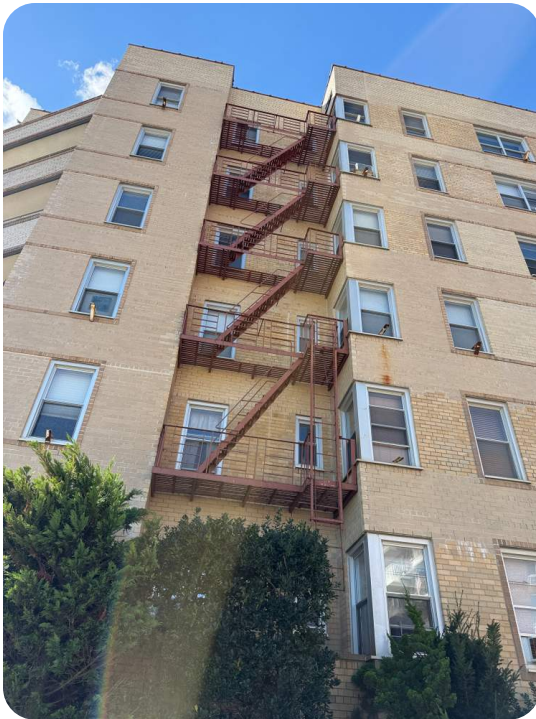
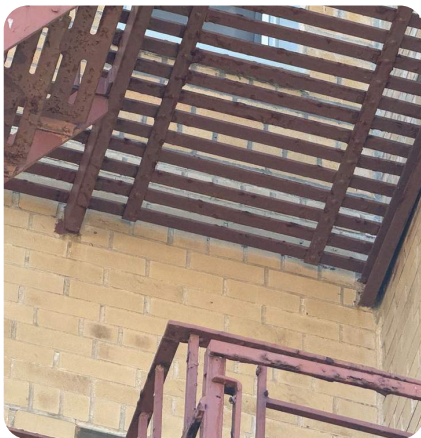
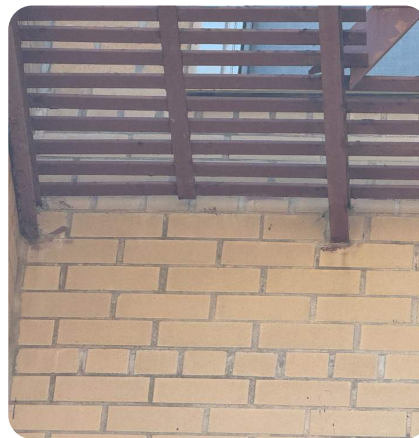
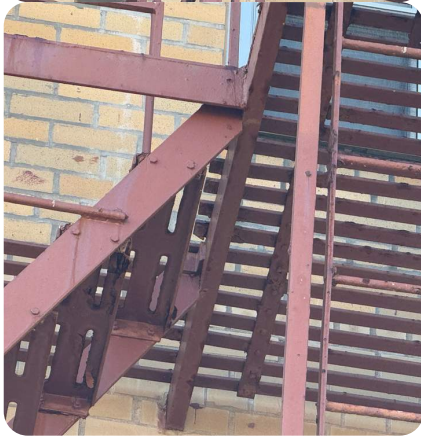
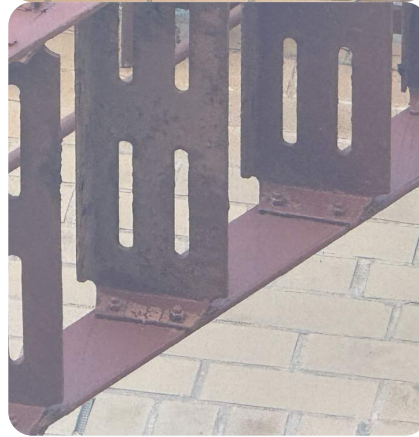
System (D)

Results: Ready for Load Test with Deficiency Report

Observed from ground level, the system appears in **fair and functional condition** with moderate surface corrosion and localized minor rust-jacking in contrast to the other front-facing systems due to reduced weather exposure. The structure is presumed serviceable pending close-up verification and load testing.
