# Load Test Report - 999 California St, San Francisco, CA 94108

### 999 California St, San Francisco, CA 94108

The Mark Hopkins Hotel is a 19-story historic landmark atop Nob Hill, featuring a chateau-style design with brick, stone, and ornate terracotta detailing with 5 fire escape egress systems.

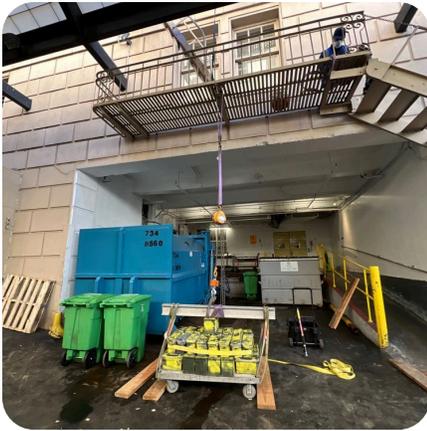
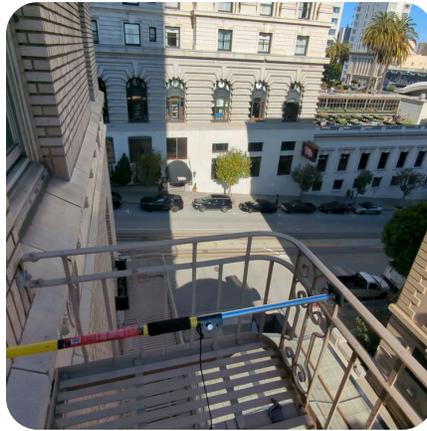
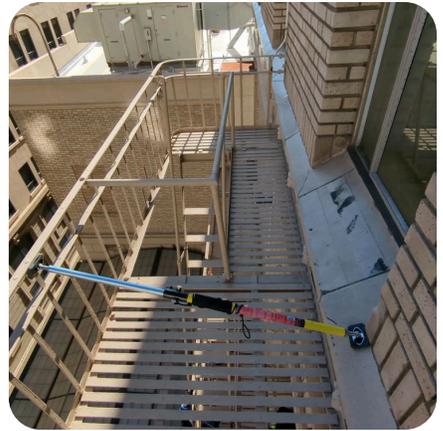
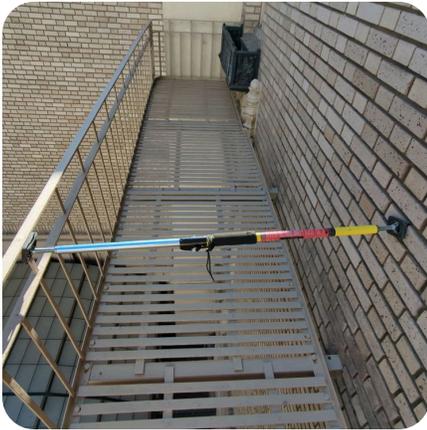
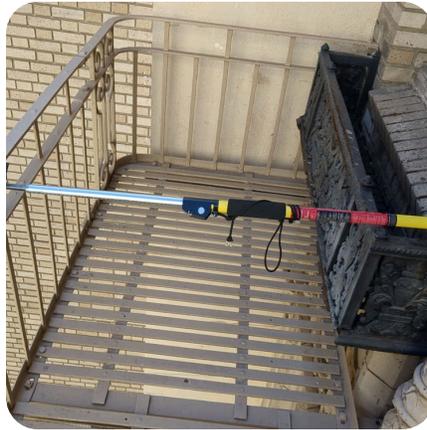
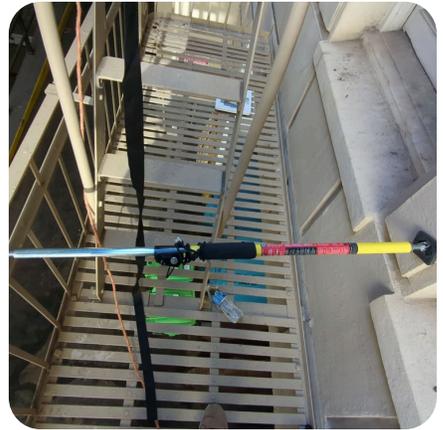
The fire escape has successfully passed a live load test of **100 pounds per square foot (psf)** and a **200-pound lateral load test** on the guardrails, in accordance with applicable code requirements.

In addition to load testing, a **visual evaluation** was conducted. During this evaluation, several minor **deficiencies** were identified. The following **corrective actions** are recommended to address these observed issues and ensure continued structural integrity and code compliance.

- Discontinuity observed at platform slats, creating potential trip hazards. Preexisting nonconforming.

Install additional slats to ensure a continuous walking surface and eliminate trip hazards.

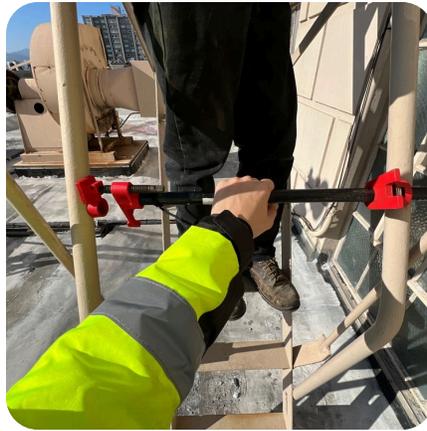
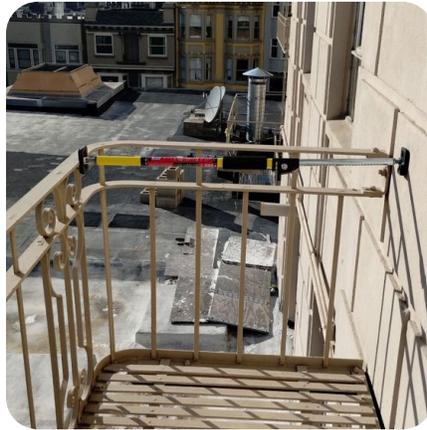
The fire escape system has passed required structural load tests without deficiencies. The paint is in fair condition. The counterweight stairs system has been found to be left in a down position, and exhibits minor signs of deterioration, including discolored (brown) cables indicative of insufficient maintenance, as well as corrosion on the pulley discs and the counterweight box.

In addition to load testing, a **visual evaluation** was conducted. During this evaluation, negligible deficiencies that did not prevent the system from passing were identified. System is recommended to be kept painted. Counterweight system should be greased if it is not intended for the inclined ladder to be kept permanently down.

Recommend to grease and maintain counterweight stairs, such that it can be brought to an up-position as needed.

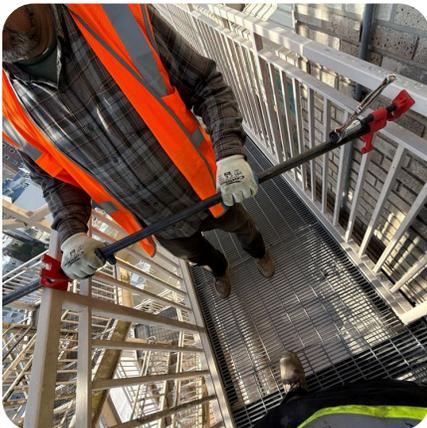
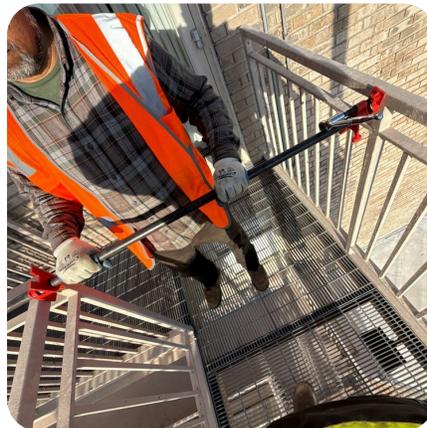
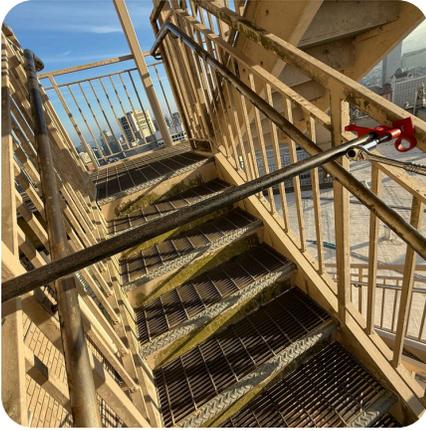
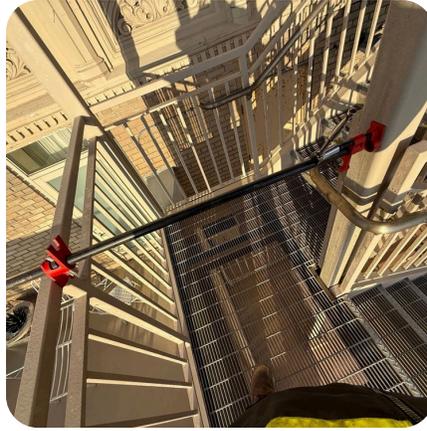
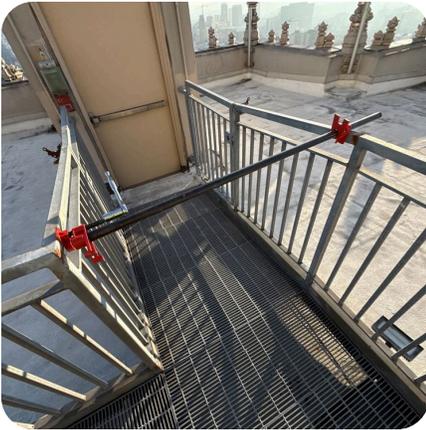
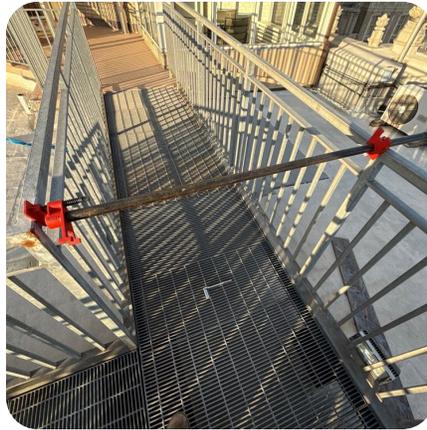
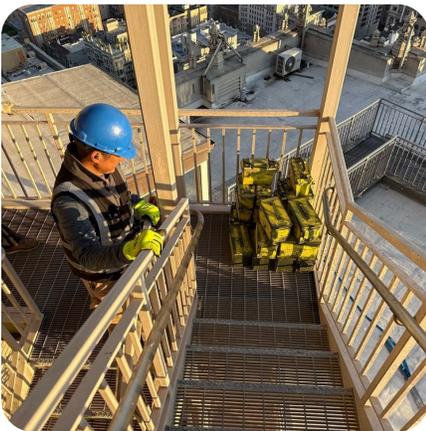
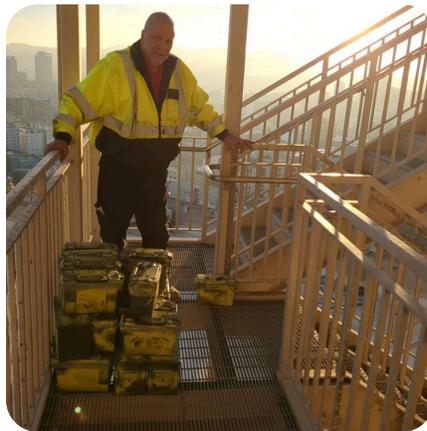
While the fire escape system has passed required structural load tests at most locations, the visual inspection has revealed multiple areas of **localized deterioration** primarily due to **corrosion and moisture infiltration**, especially at welded joints at platform shelf angles that support the grating and at some railing tube posts.

Timely corrective action, including painting, sealing, bolt replacement, and concrete repair, is required to maintain the fire escape's safety, functionality, and code compliance.
