## PRE-LOAD TEST EVALUATION RESULTS

PERFORMED AT: **C**  
side  
**720 Ocean Ave Ocean City NJ**

INSPECTION DATE **September 3 2026**  
REPORT DATE **September 9 2026**  
REPORT EXPIRES **December 9 2026**

## PRE-LOAD TEST INITIAL EVALUATION PASS/FAIL REPORT

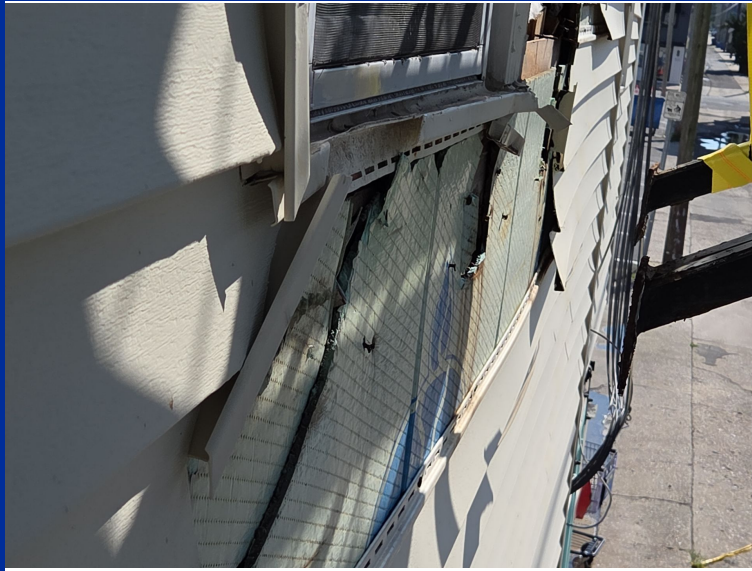
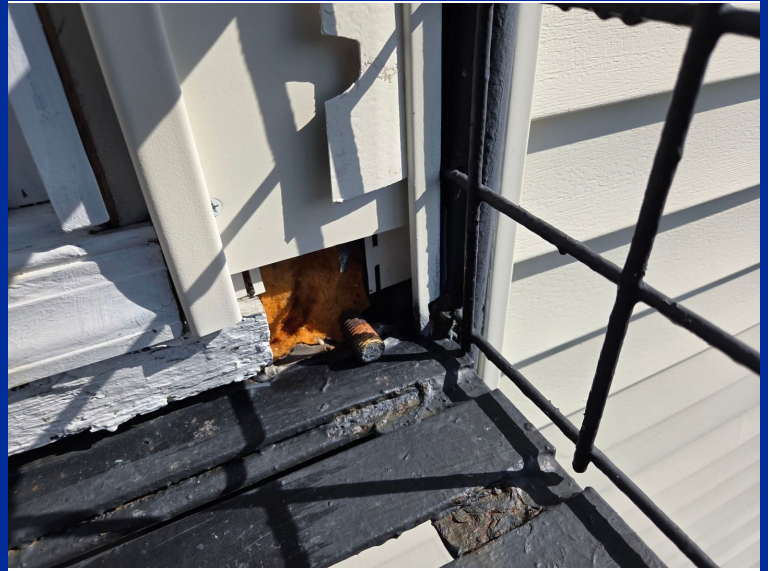
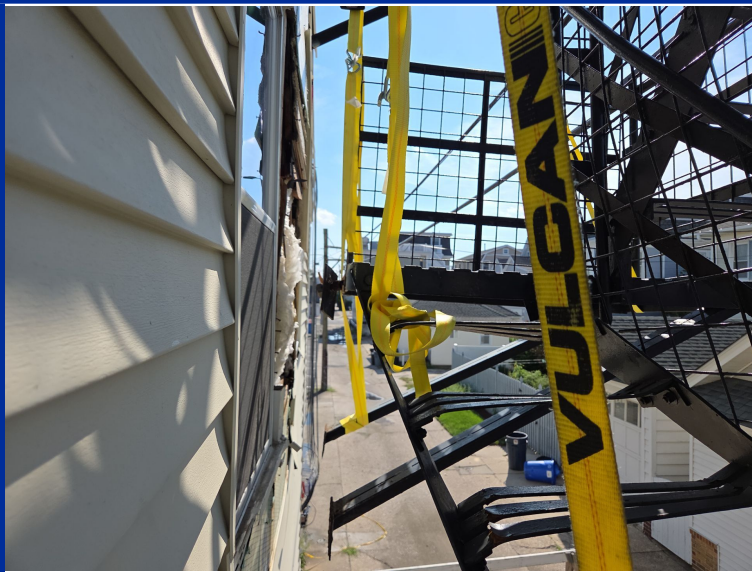
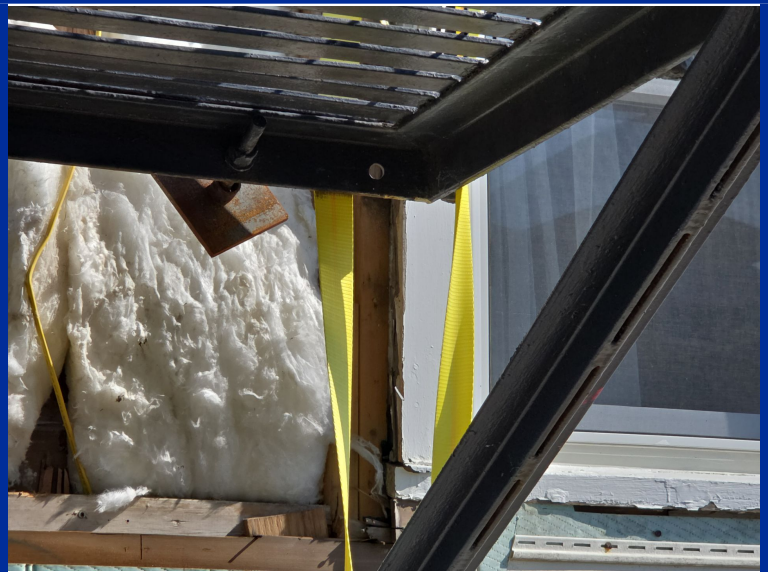
Overall Major Structural FAIL. Internal rust causing Rust Jacking (RJ) of all suspect connections.

Overall Major Structural Supports thru-bolt FAIL: Through bolts and plates pulled out of wall

Overall Major Structural Platforms, Slats, Grating FAIL. Platform damaged by collision impact

Overall Major Stair Stringers FAIL. Clips to stringer damaged by collision impact

Overall Major Structural Treads FAIL. Treads damaged by collision impact.

Overall Major Structural FAIL. Railings damaged by collision impact.
